# MEMORANDUM

Subject: Notes and Revised Geologic Map for Tyler Property Field Visit, January 13, 2017

### Descriptions of Stops During Field Visit to Tyler Property, January 13, 2017

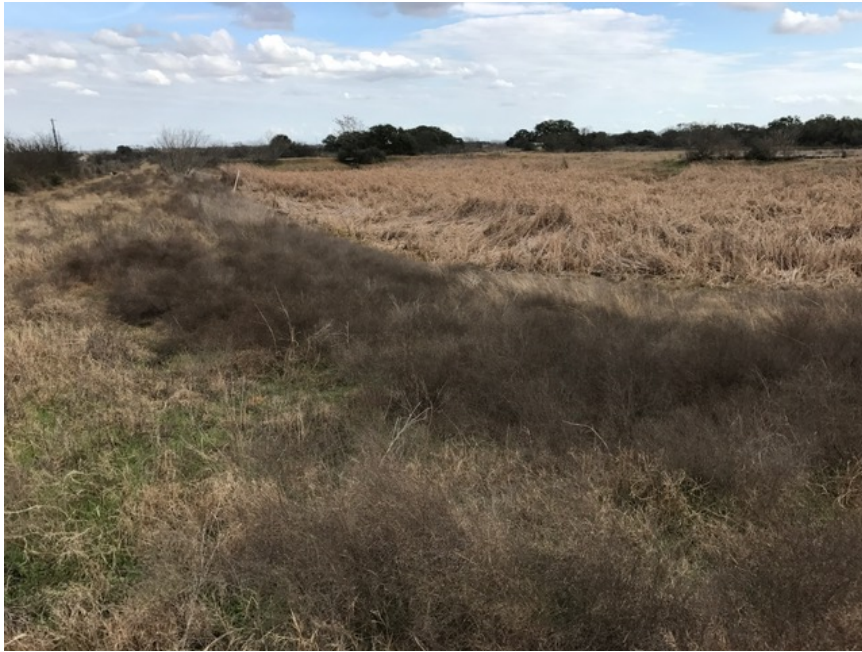
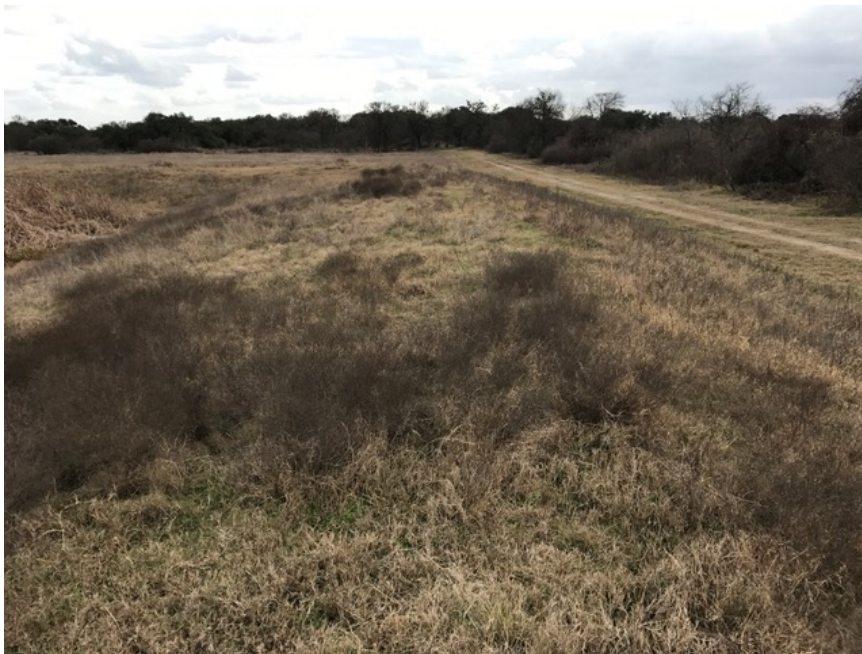
Observed Del Rio excavated with surrounding embankments. Rectangular shape. Apparent Del Rio excavation down to Georgetown. Standing water and water plants (cattails) observed.

A. Rectangular Impoundment Cut in Del Rio Formation, (Above – Eastward View of North Embankment; Below, Southward View of West Embankment) (Stop 5)

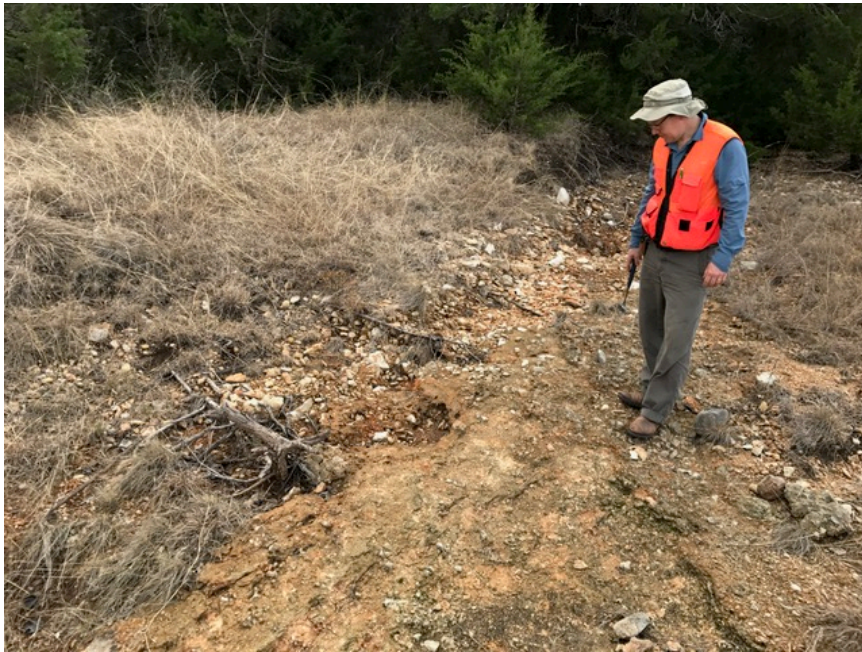
Tried to confirm Del Rio. Found Georgetown bedrock instead on south side of fence. Remapping needed.

C. Georgetown Formation Outcrop with Overlying Rounded Pebbles and Cobbles of Terrace Gravel Deposit (Stop 8)

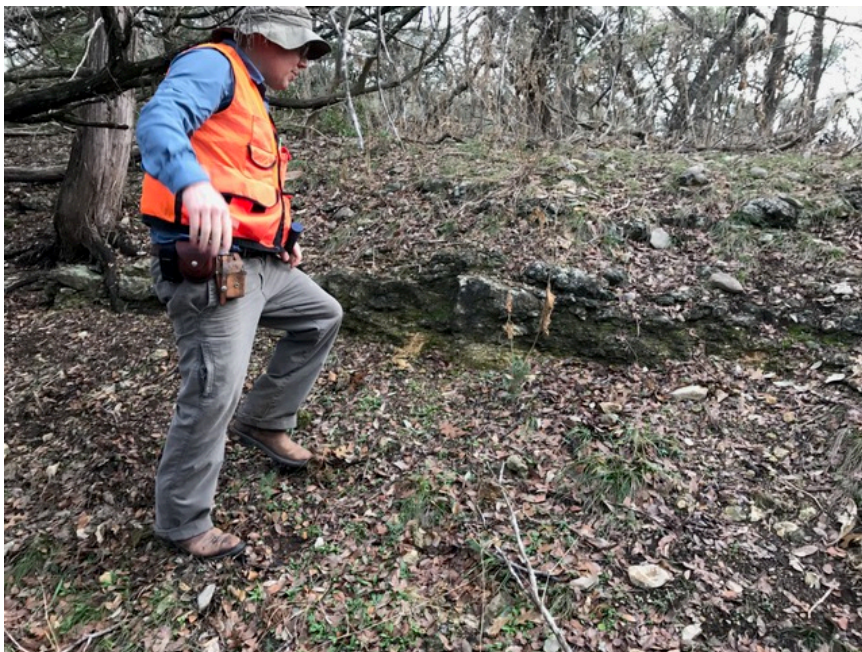
Georgetown apparently extends north to the hilltop at Stop 8. Need to remap. Walked up the creek but observed no more outcrops.

C. Georgetown Formation Outcrop on North Bank of Small Onion Creek Tributary the Near East Boundary of Tyler Property (Stop 9)
