### MEMORANDUM

Subject: Geologic Field Trip to Northeast Corner of Mt City and Surrounding Quads

(Elliott Ranch Area), August 17, 2017

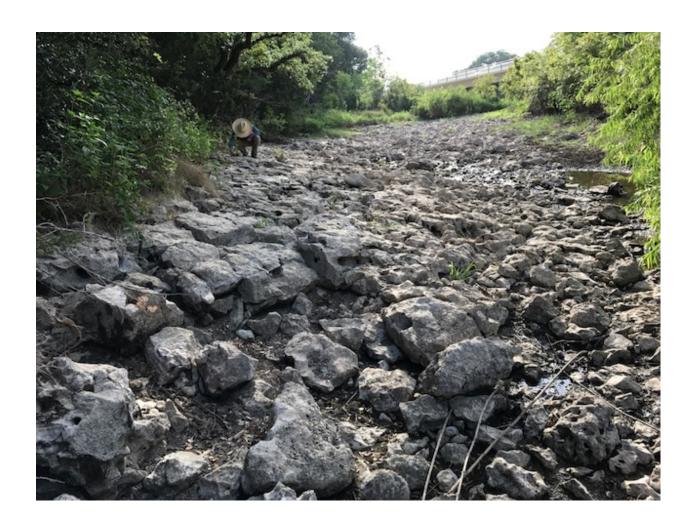
- 1 Kbu outcrop upstream of bridge over Little Bear Creek on FM 1626. Fractures N130E, dip due south. Photos in Attachments D1 and D2.
- 2 Kgt north of FM1826 and Hardin Loop (County 311).

D1. Stop 1. Downstream View of Kbu Outcrop in Channel of Little Bear Creek. FM 1626 bridge can be seen in background. Note beds dipping to right (south)

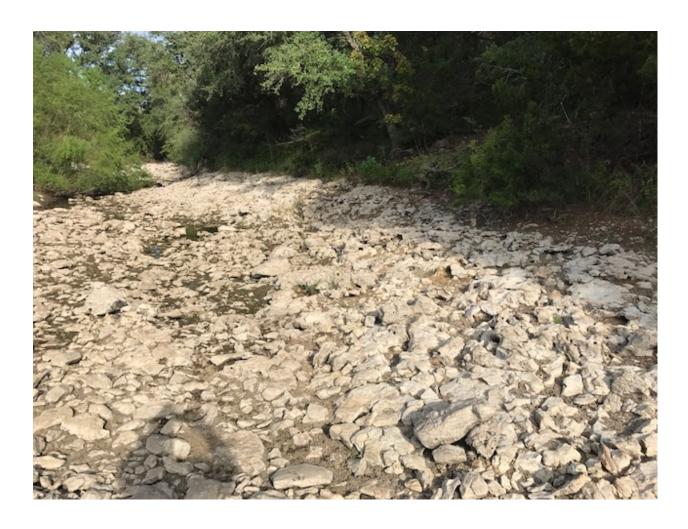
D2. Stop 1. Upstream View of Kbu Outcrop near FM1626 Bridge over Little Bear Creek

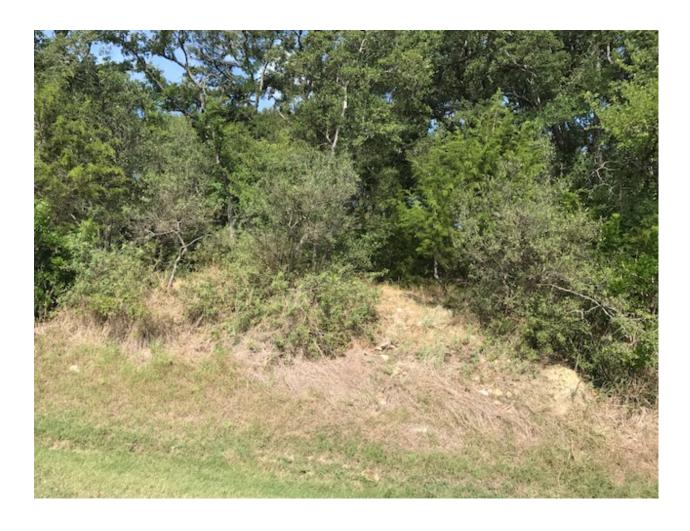
- 8 Kgt on Ked in fault block. Reinterpret previous Kdr exposed through Kbu.
- 9 Kbu cap on Kdr on west side of road. Photo in Attachment D3.
- Fault with northeast trend. Kdr on west and Ked on east. Sharp vegetation demarcation to northeast. Photos in Attachment D4 and D5.

D3. Stop 9. Kdr Outcrop on West Side of Road at Stop

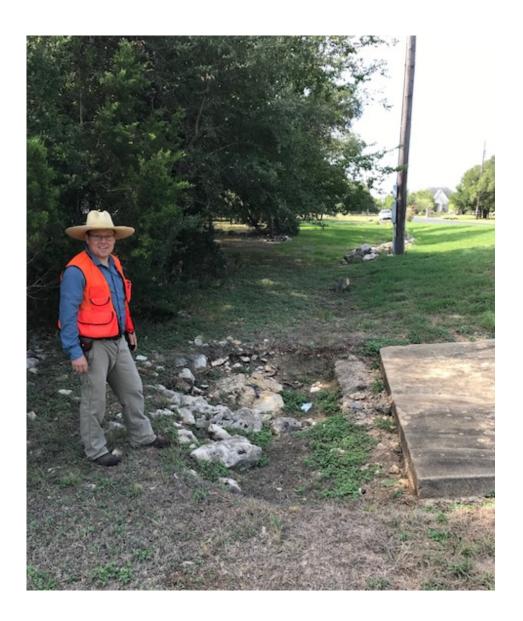
D4. Stop 10. Outcrop of Fault between Ked on Left and Kdr on Right in Front of Brian Hunt.

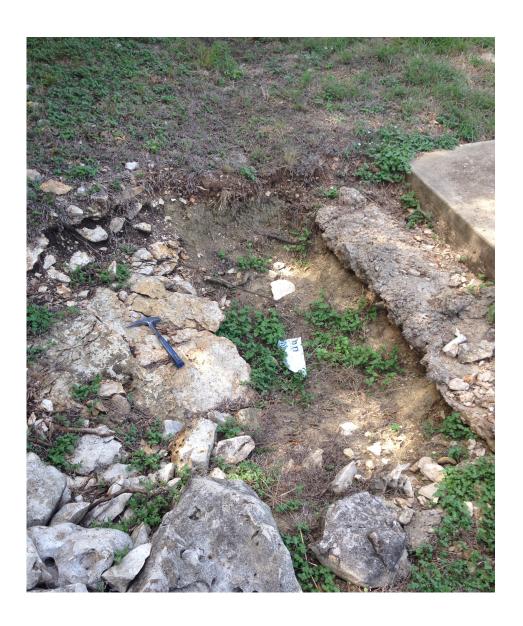
D5. Stop 10. Closer View of Fault in Figure E3, with Ked on Left under Rock Hammer and Kdr on Right.
