## MEMORANDUM

Subject: Dahlstrom Ranch Second Field Visit, December 15, 2016

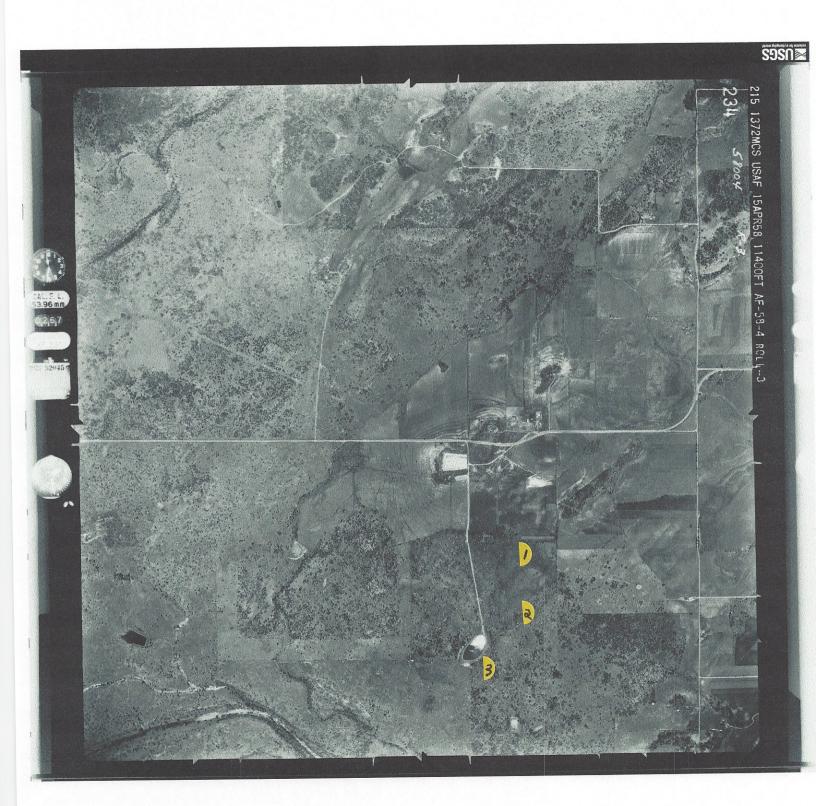
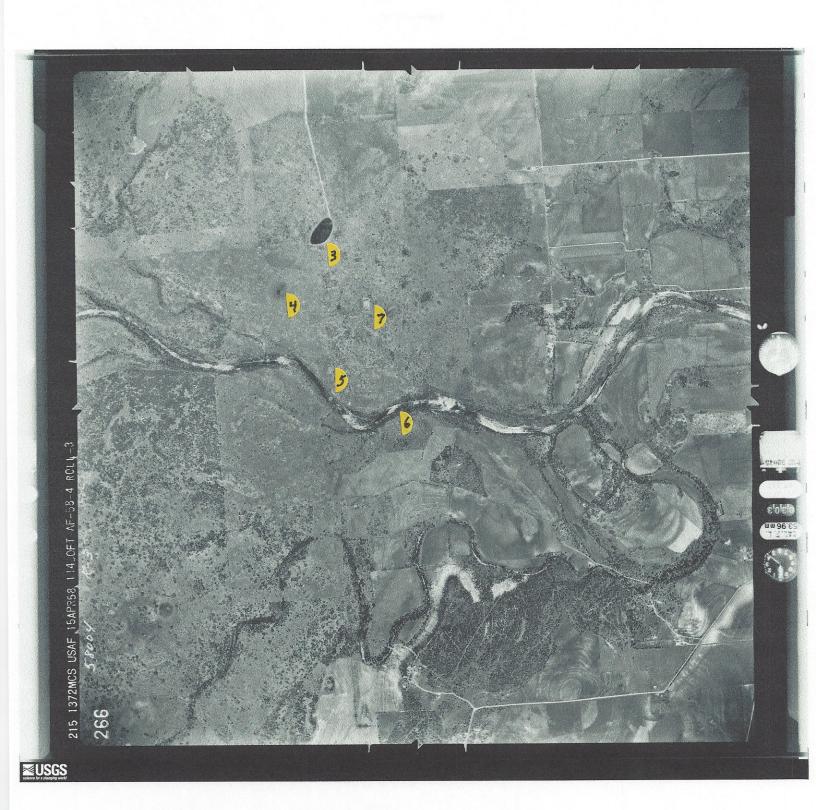
## Attachment A.

Dahlstrom Ranch Field Stops, December 15, 2016 on 1958 Air Photos (Two Photos)

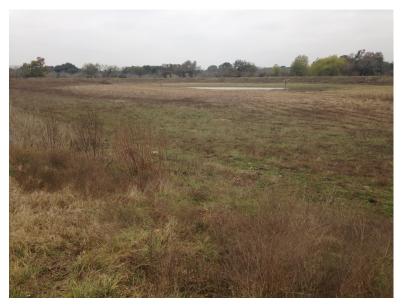
Large area with small pond in southwest portion of sink.

Highly modified with embankment around the perimeter, nearby water well for filling the impoundment, a connecting pipeline, and a permanent dock.

Pond shown is in southern part of the sink. Embankment around the sink is shown in the foreground and behind the pond.

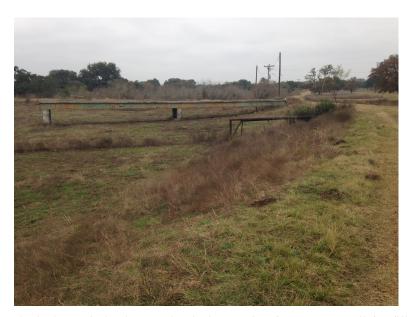
Inactive dock shown in background. Discharge pipe from water well for filling the impoundment is shown in the foreground.

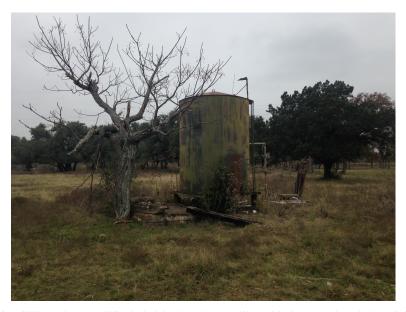
Water well for filling the modified sinkhole. The wellhead is just to the right of the tank. The water line leading to the sink extends from the wellhead in the other direction and toward the discharge pipe in the above photo.

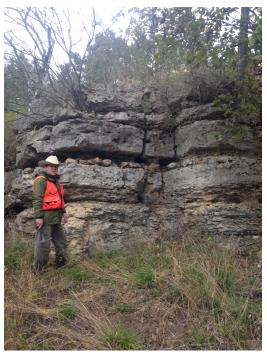
Observed marly bed overlain by competent burrowed limestone beds continuously along the extent of the outcrop.

Concluded the outcrops were of Edwards limestones.

Brian Hunt is standing near the Edwards outcrop. Note the marl zone in lower part of the outcrop and resistant burrowed limestone in upper part. The contact is just above Brian's waist line.

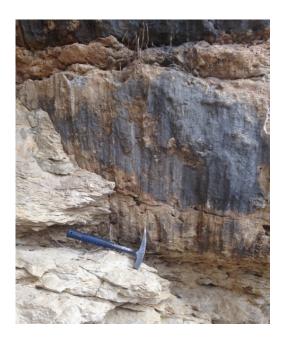
Small-scale structural disturbances seen, including gently dipping beds and small-displacement falls.

Small-displacement normal fault with slickensides on the hanging wall side of the fault.

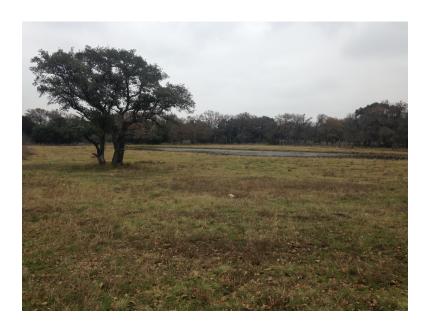
Small Sink near East Boundary of Dahlstrom Ranch

Confirmed small sinkhole
