# MEMORANDUM

To: Brian Hunt, Kevin Thuesen, Justin Camp  
From: Tom Grimshaw  
Subject: Notes for Geologic Field Trip to Sky Ranch, May 22, 2017

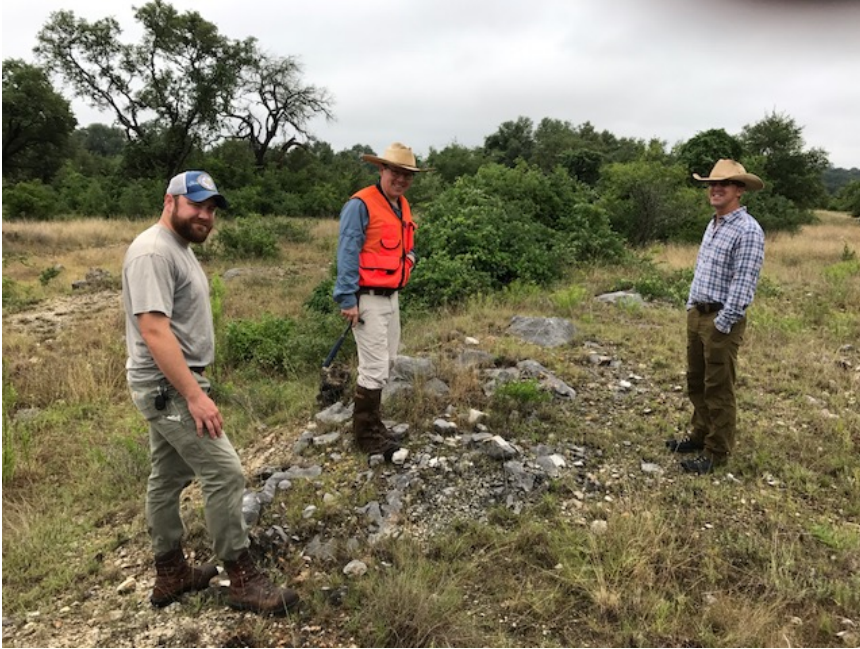
- Observed evidence of major intra-Edwards fault
- Consisted primarily of gently dipping beds and other signs of structural disturbance
- Appears to be and I'll crop of the Regional Dance Member
- Extension of fault mapped in Rutherford Ranch

Structural Disturbance along Fault. Justin Camp (Left), Brian Hunt, and Kevin Thuesen.

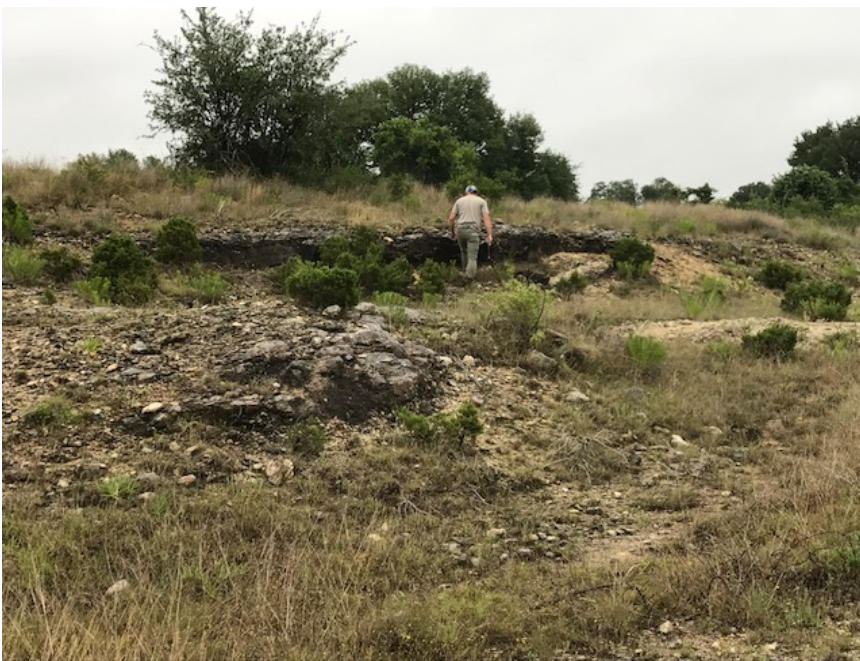
Outcrop of Apparent Regional Dense Member. Beds Are Dipping into the Hill in Front of Justin.

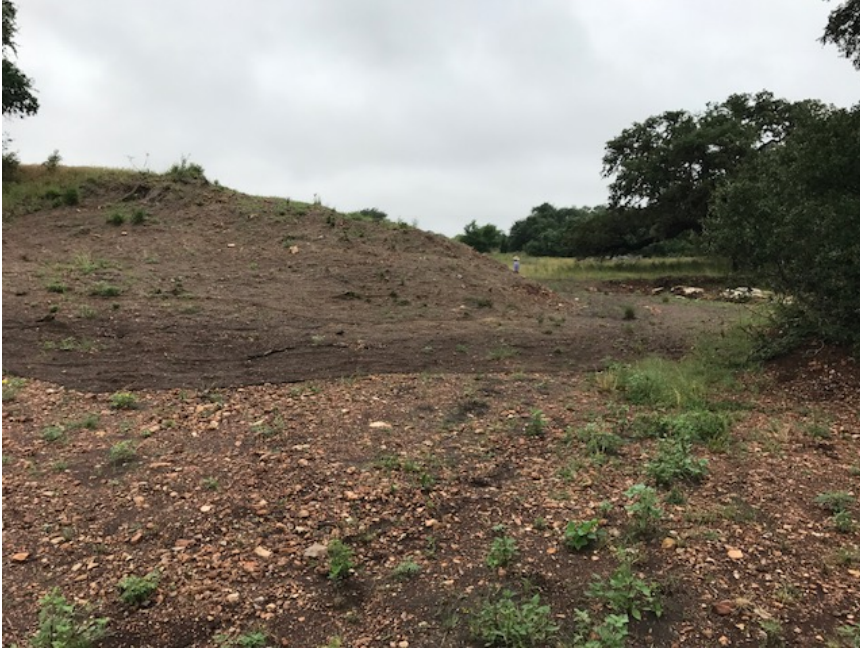
- Embankment and impoundment were washed out during a recent flood
- The stream channel is scoured, exposing outcrops of Edwards limestone
- Prominent "honeycomb" texture was observed

Breached Embankment, Shown on the Left, and Scoured Channel (Right) Resulting from a Flood Event.

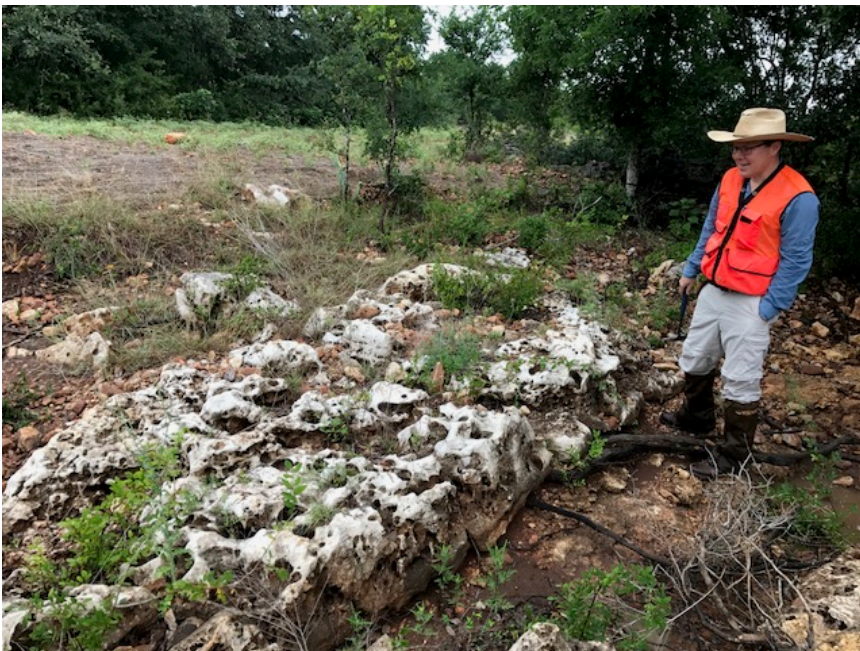
Bedrock in Scoured Channel, Showing Burrowed (Honeycomb) Edwards Limestone Beds. Brian Hunt on Right.

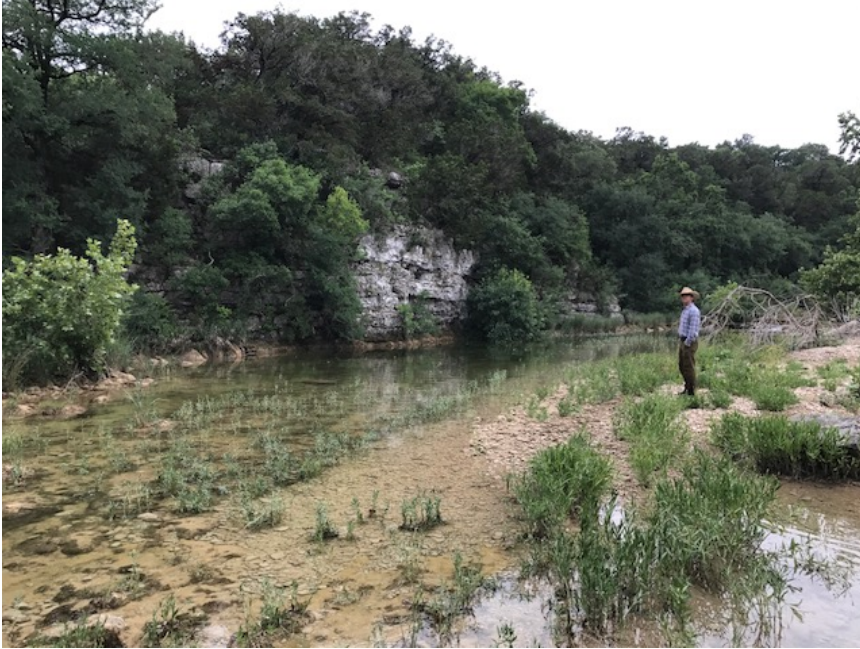
- No evidence of faulting observed in outcrops along Onion Creek
- Continuous, uninterrupted strata noted
- Fault maybe located further north in Sky Ranch

Southwest View across Onion Creek, Showing Cliff of Edwards Limestones. Kevin Thuesen on Right.

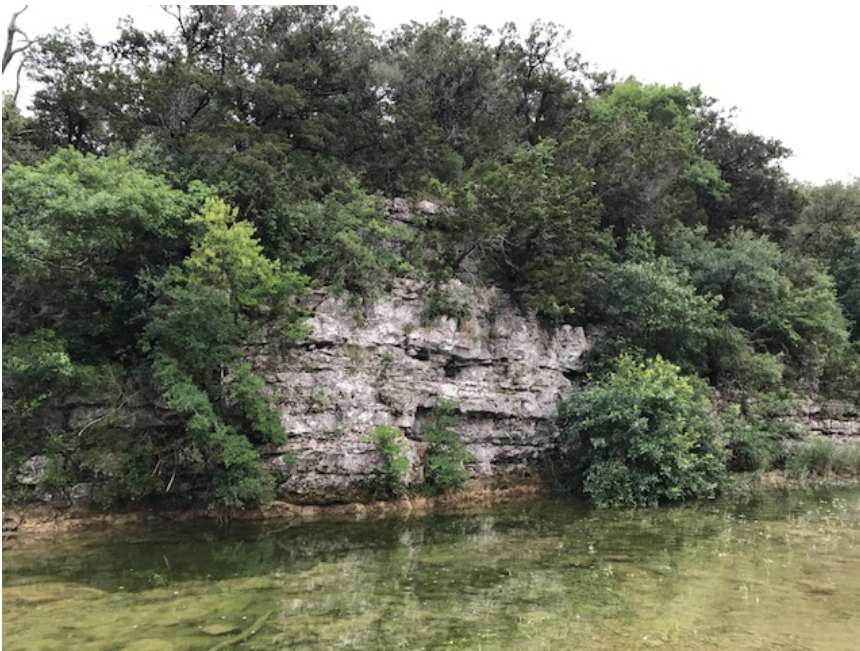
Closer View of Edwards Limestone Outcrop on South Bank of Onion Creek. Note Flat-Lying Strata (No Fault Evidence)

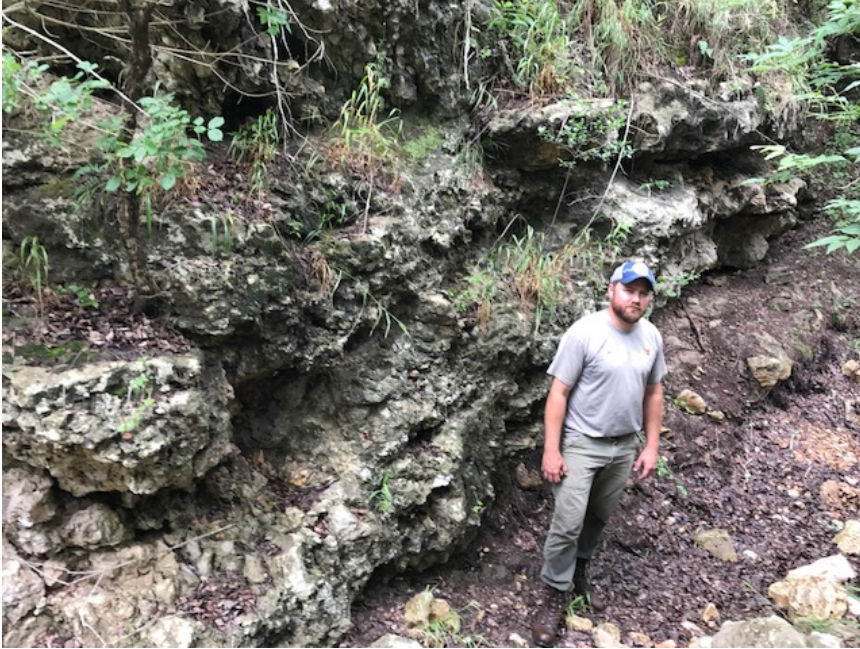
- No evidence of faulting was seen on in the ravine west of the crossing on the south side of the crossing
- However, good evidence of a fault was seen in the ravine on the east side on the south side
- Primarily dipping beds and discontinuous strata

Evidence of Fault in Ravine Southwest of Low Water Crossing. Justin Camp in Foreground. The Fault Appears to Be Above and to the Left of Justin.

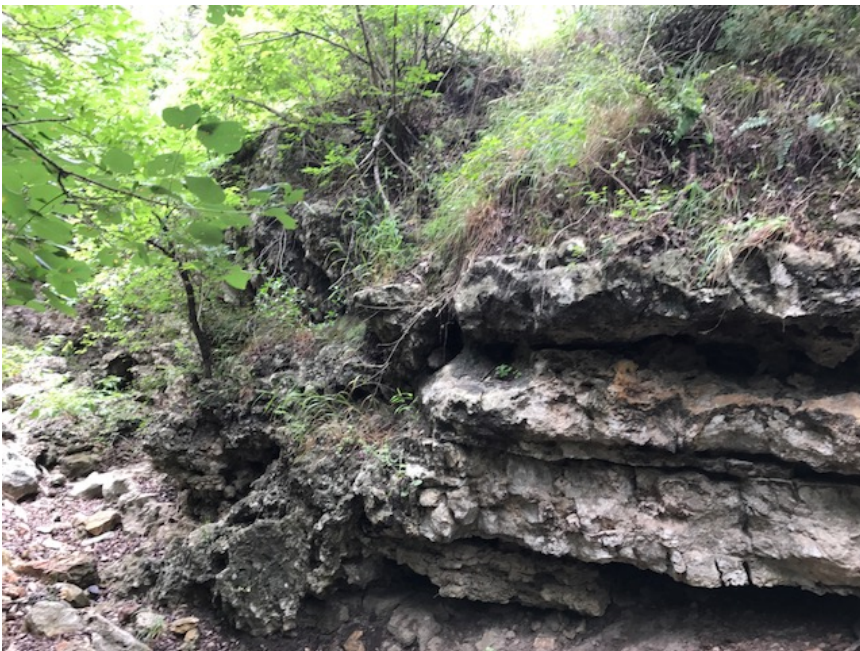
Another View of the Fault, Showing Truncation of the Limestone Beds on the Left. Outcrop Showing Beds That Are Dipping into the Side of the Small Stream. Brian Is Examining the Fault Evidence.

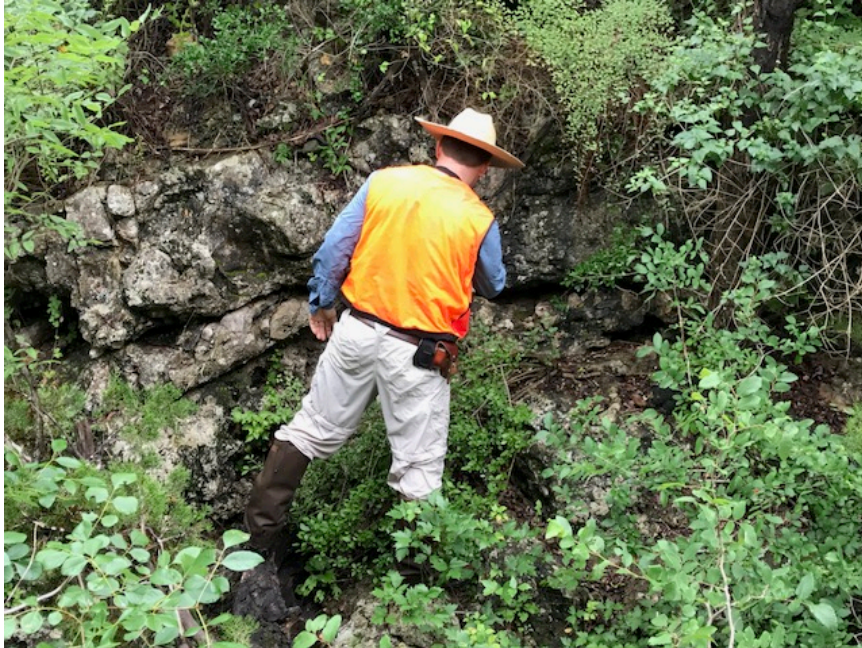
Outcrop Showing Beds That Are Dipping Into the Bank of the Small Stream. Brian Is Examining the Fault Evidence

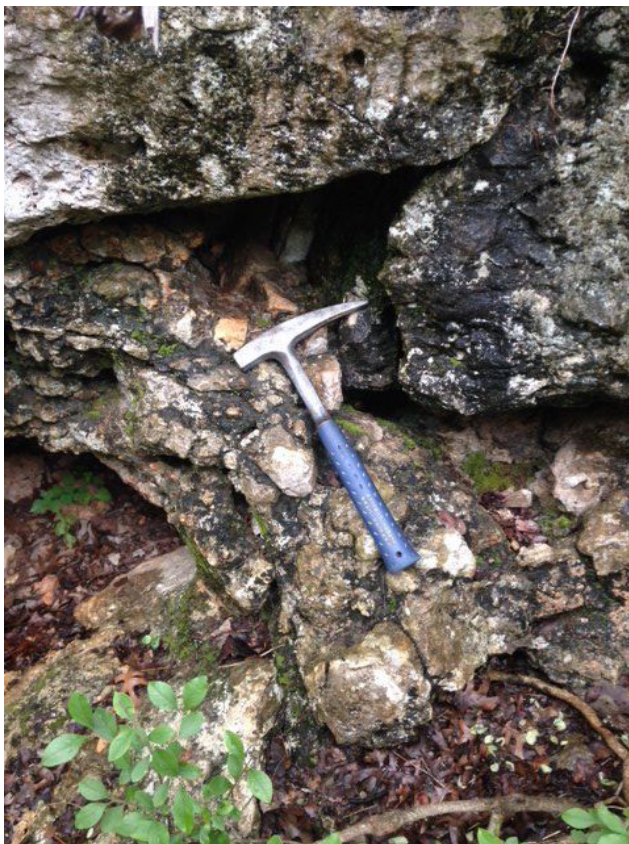
Closer View of Outcrop, Showing Possible Fault Gouge as Conglomerate. Photo Courtesy of Brian Hunt.

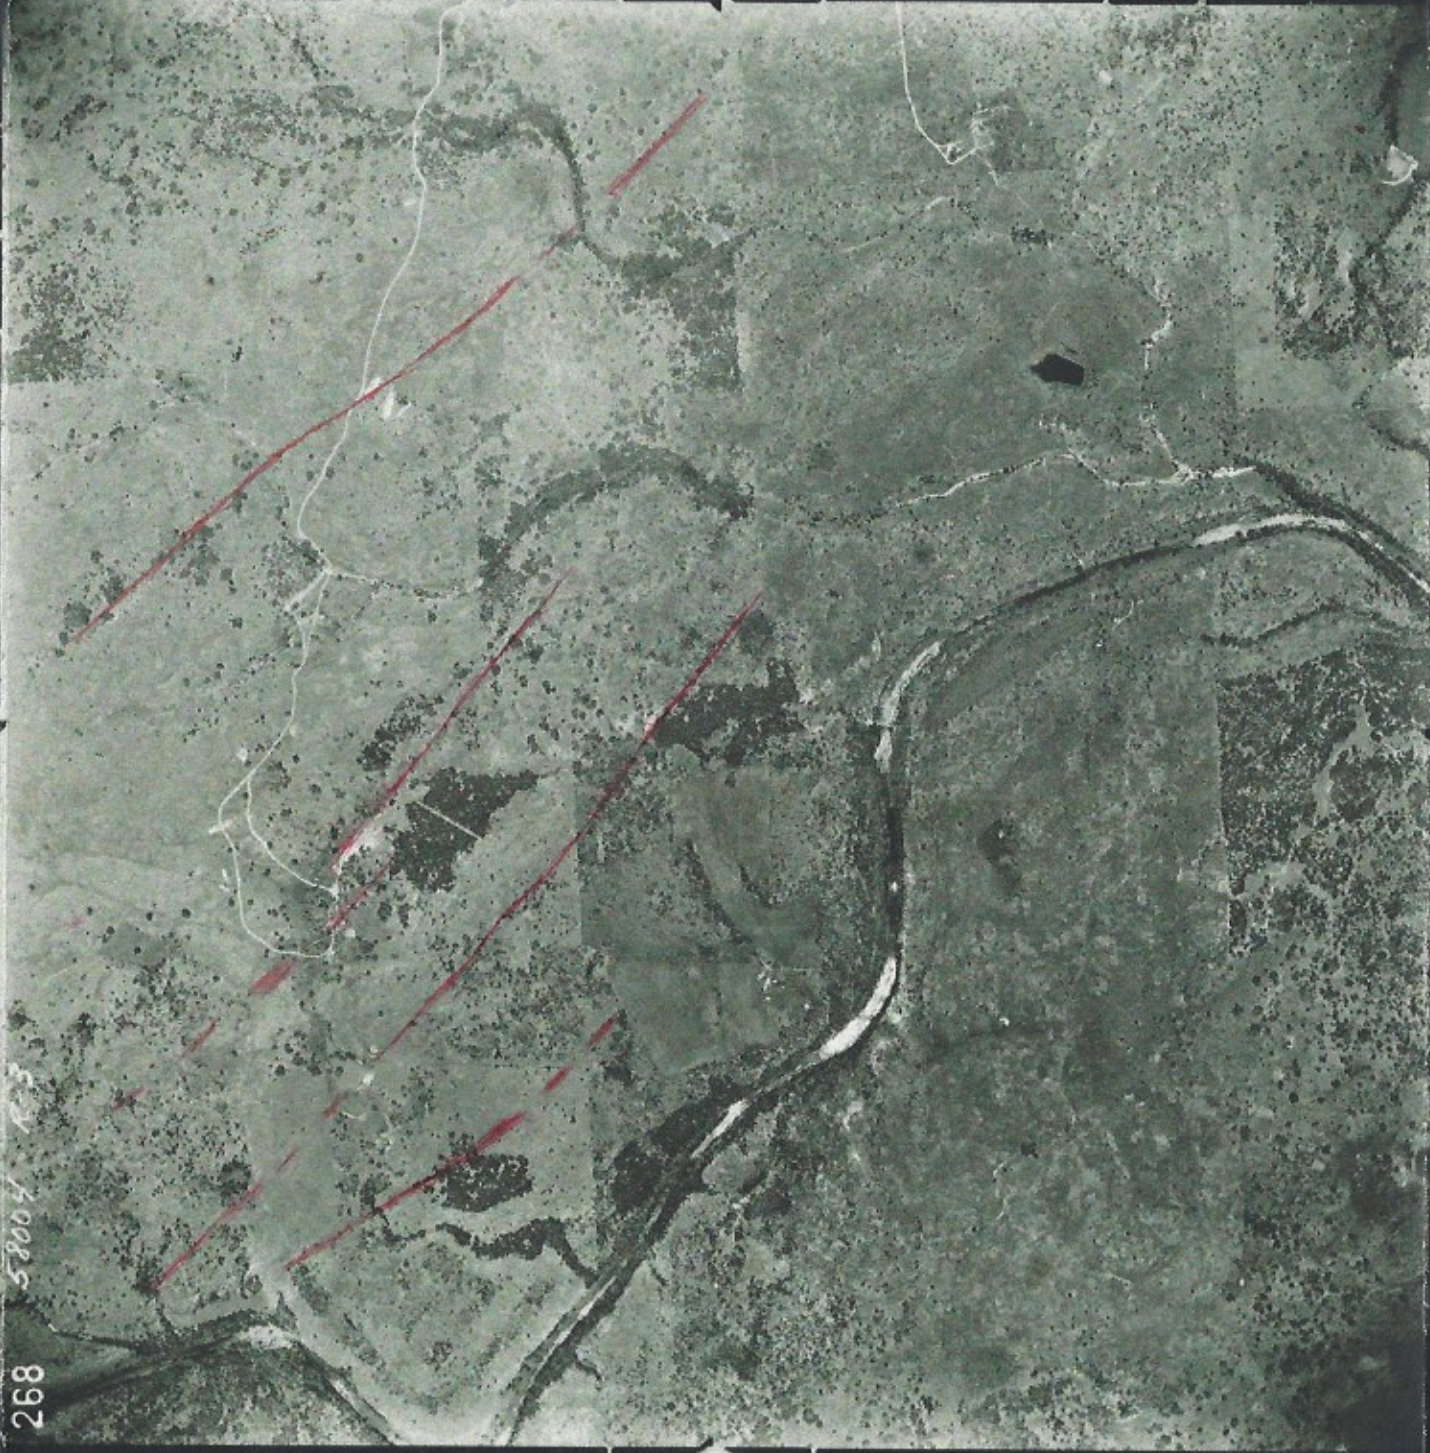
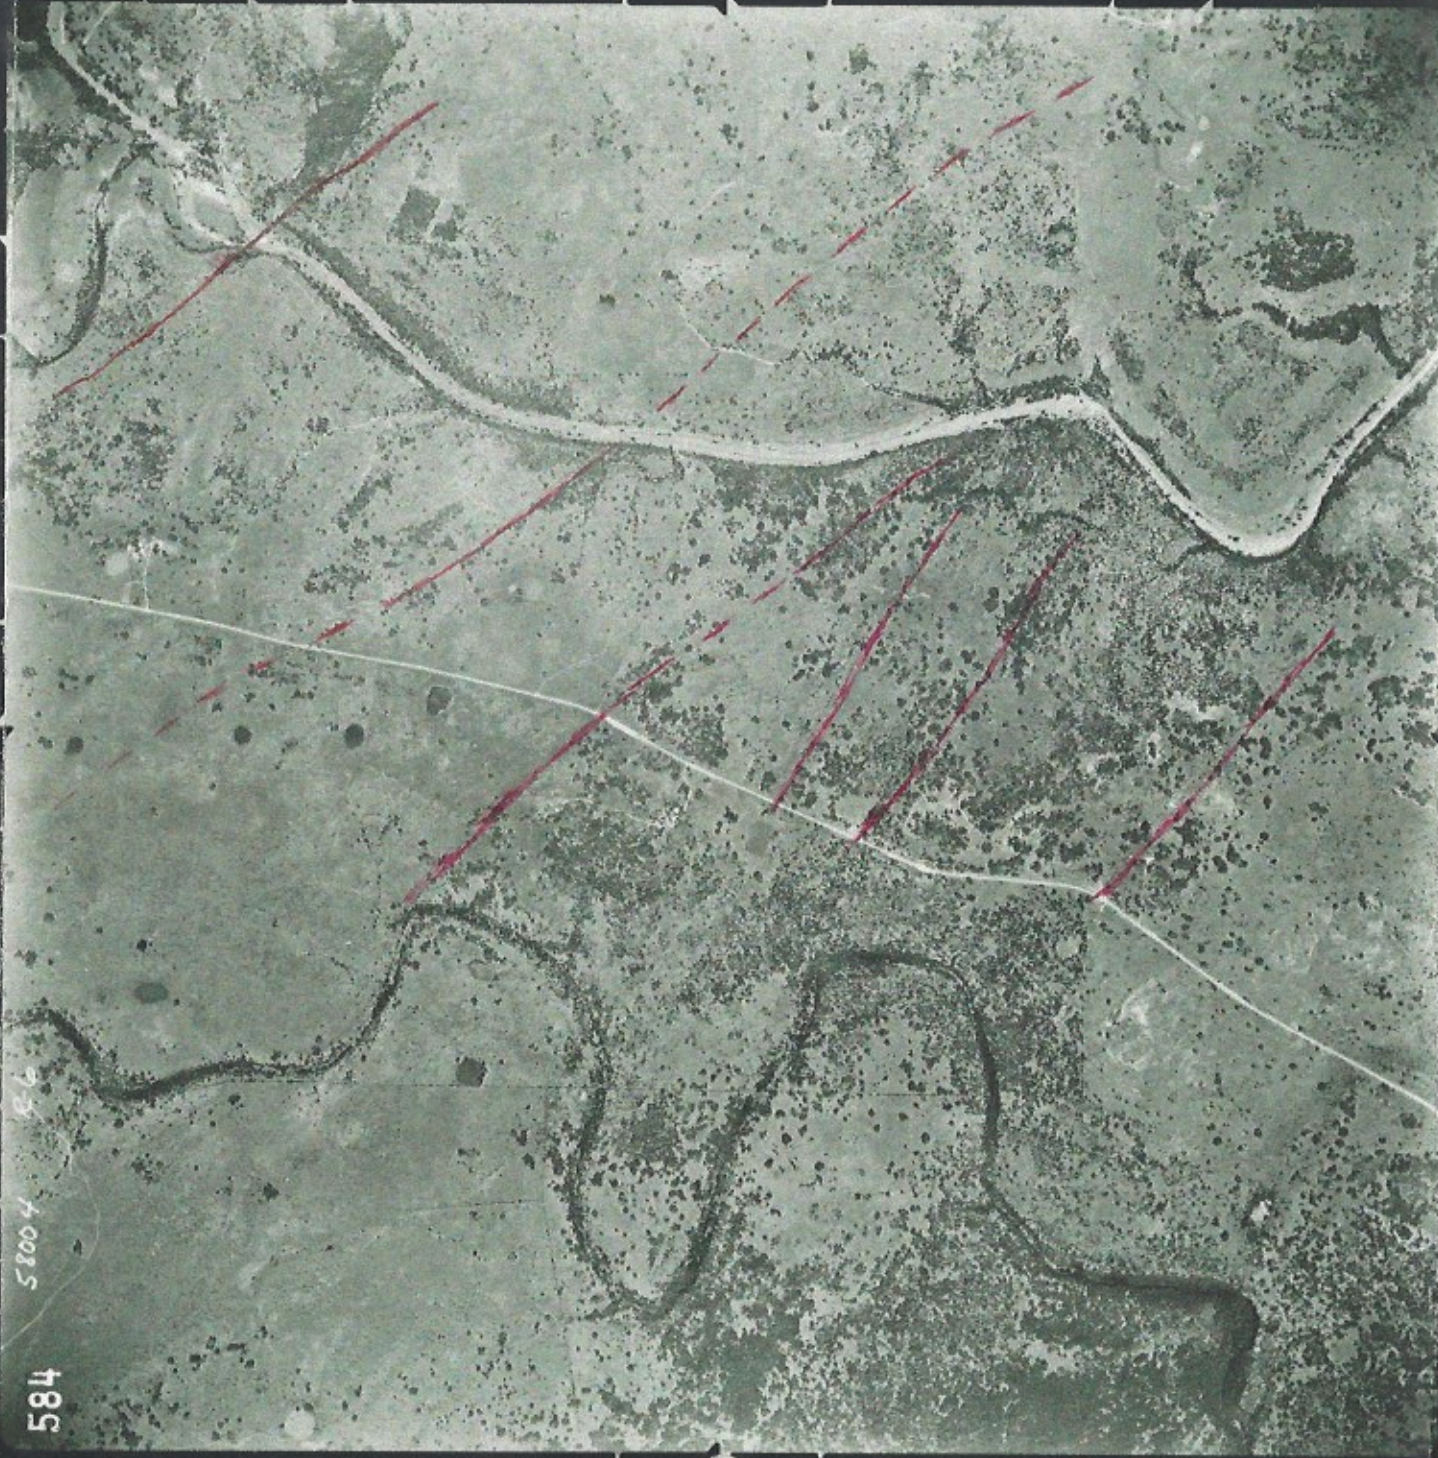
Air Photo Mapping of the Sky Ranch Tract

Air photo stereo pairs that had been mapped before the field trip were re-examined after the trip and are shown in Attachment F. A short lineation was noted where we saw evidence of faulting at Stop 6, but it was not observed to extend northward across Onion Creek.

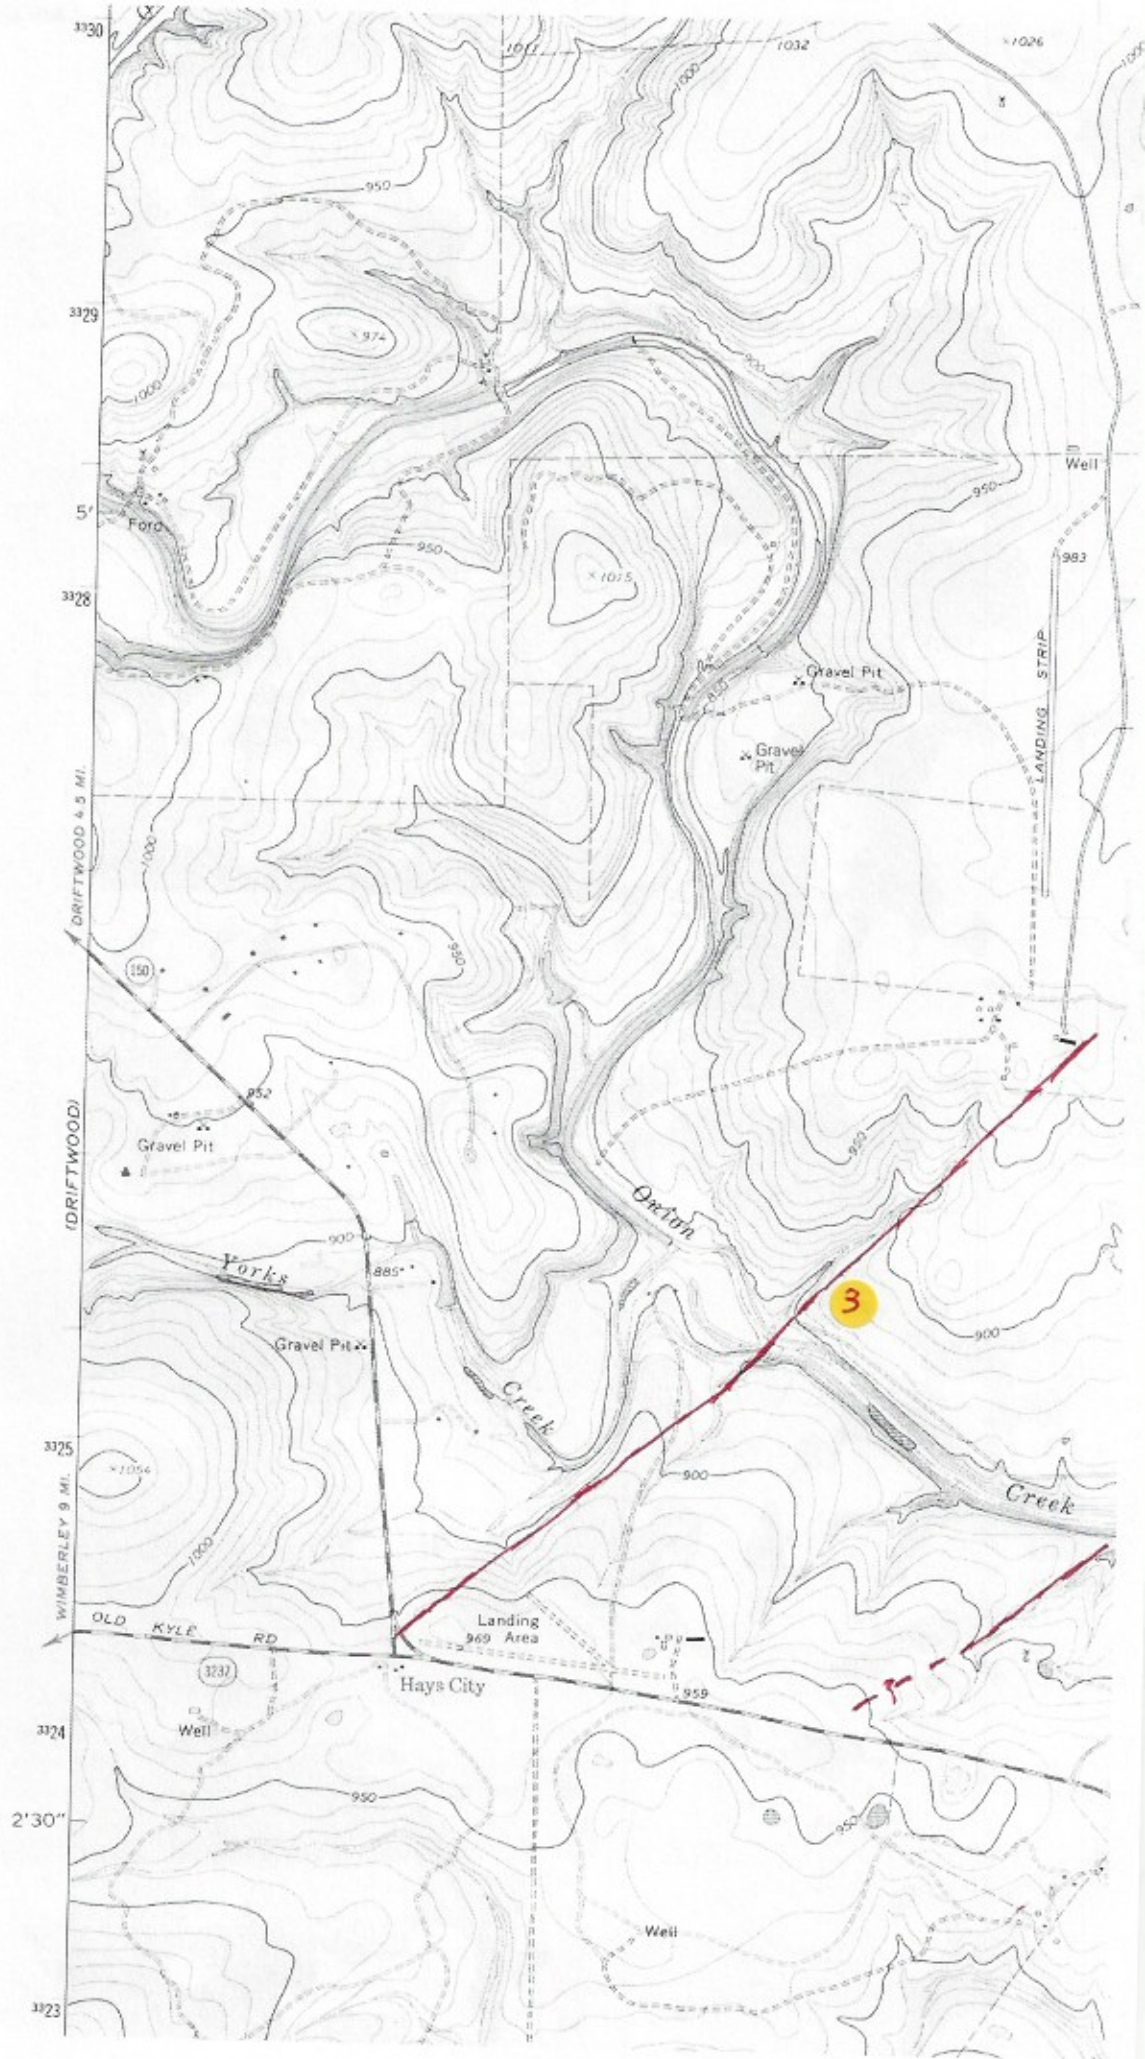
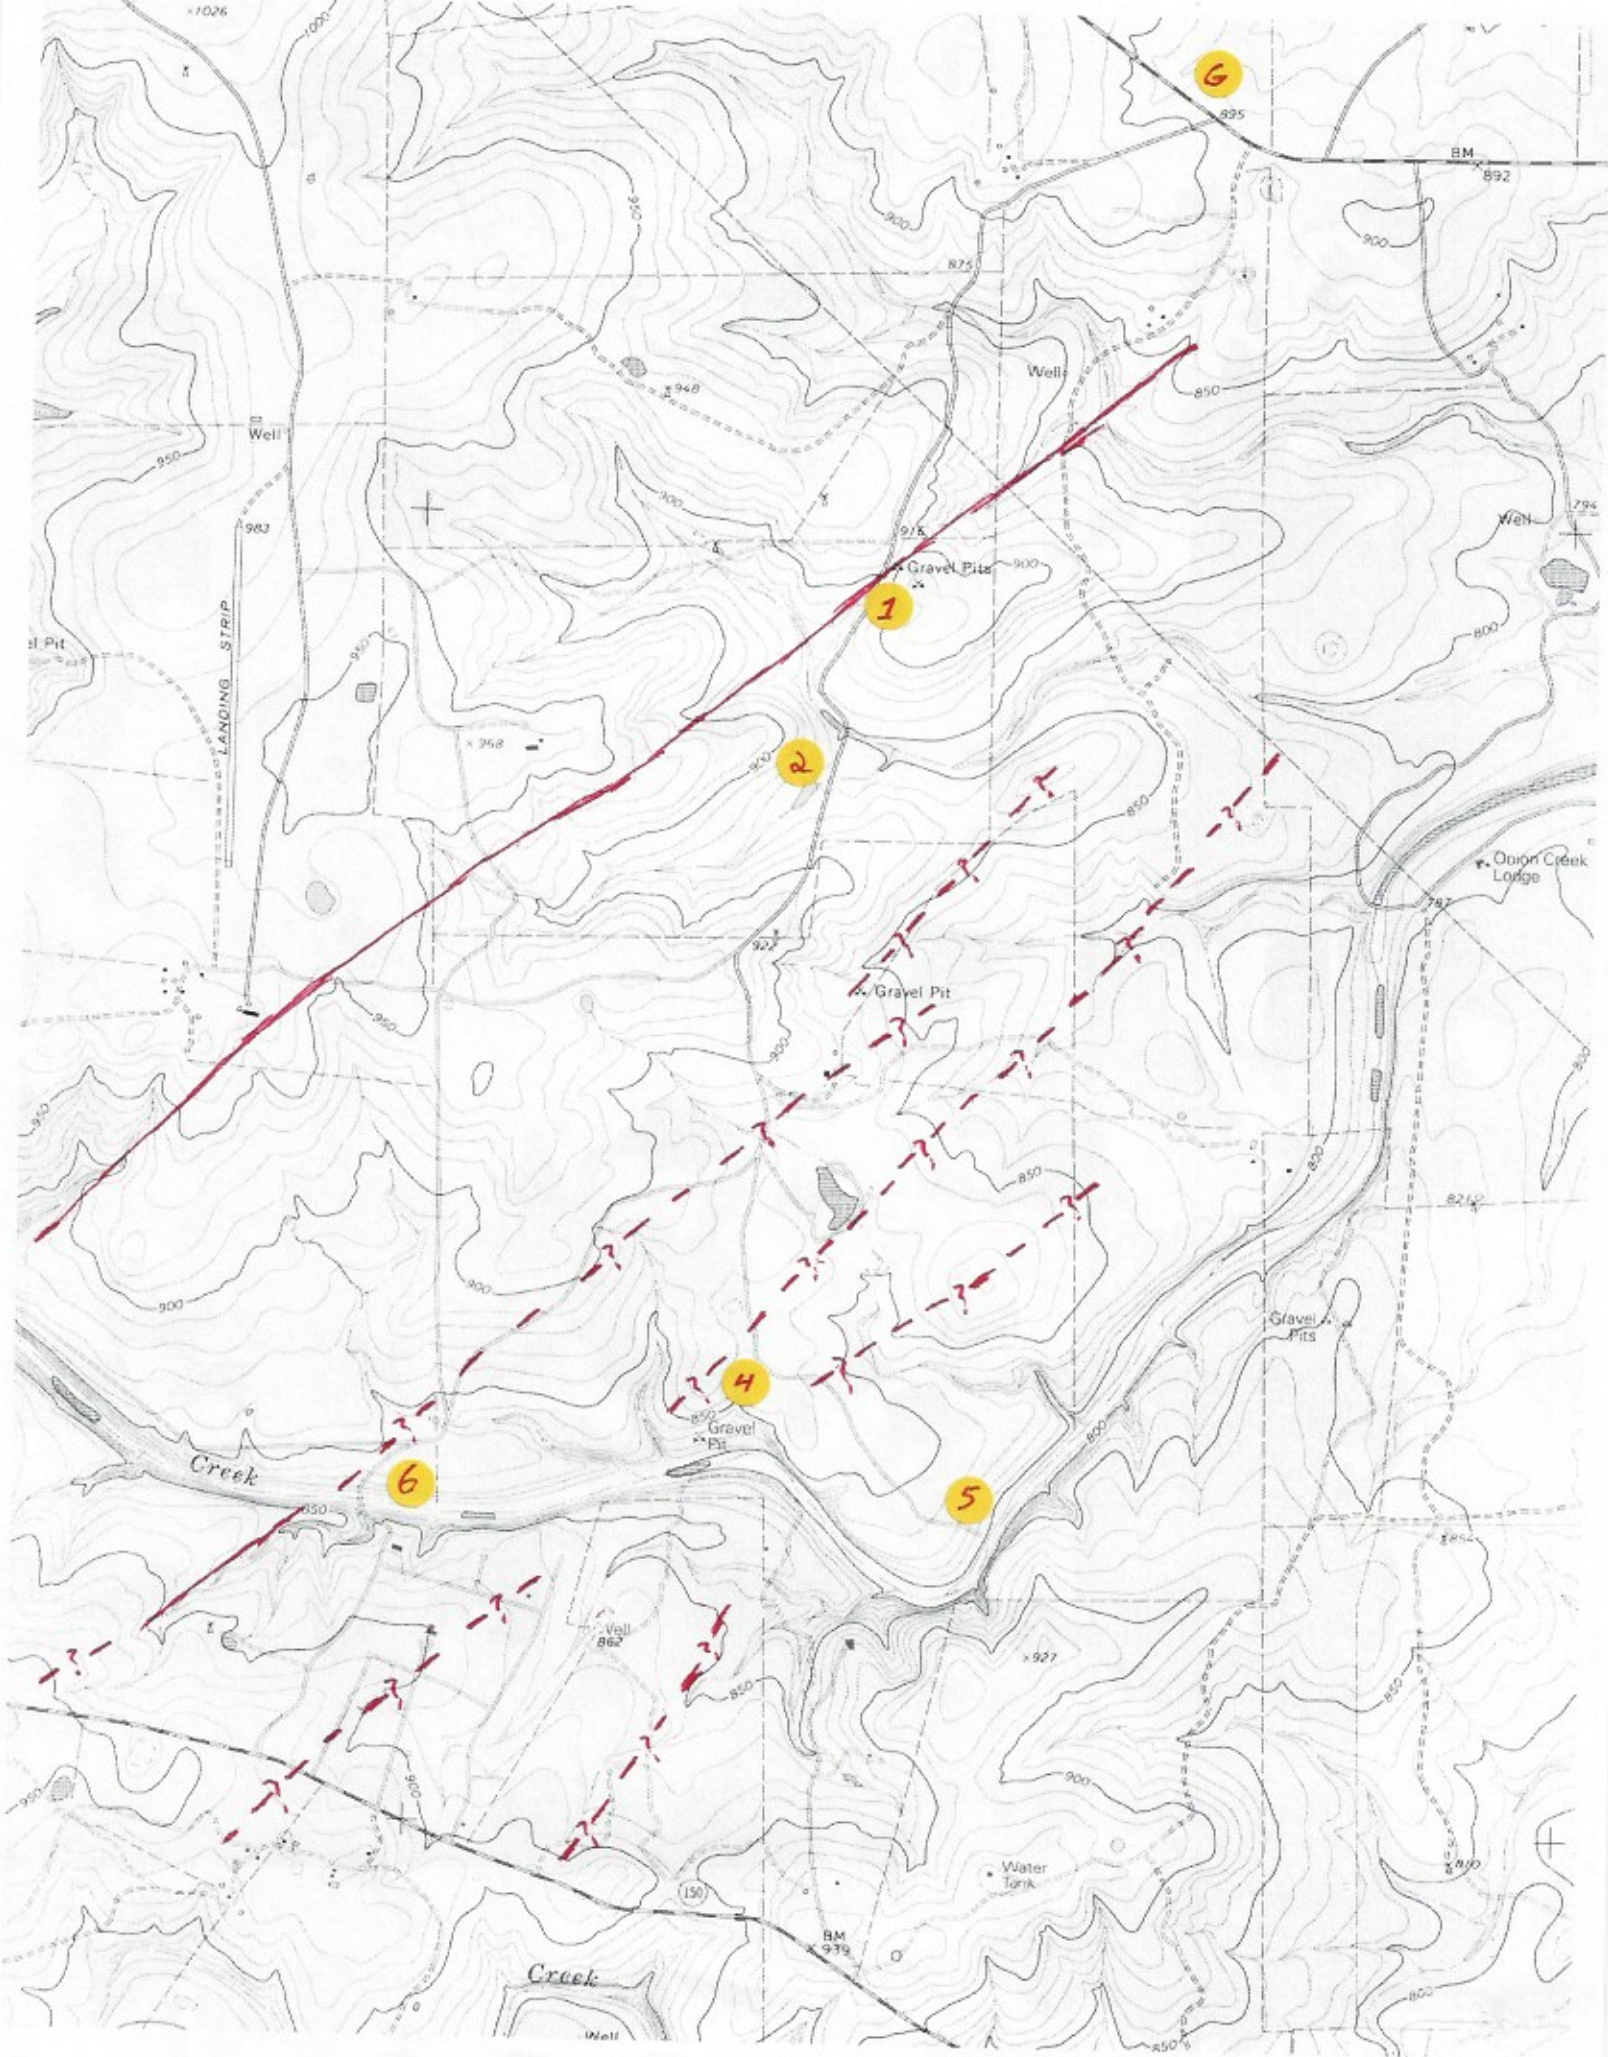
Geologic Map of the Sky Ranch Tract (Topographic Base)

Attachment G presents a geologic map of the Sky Ranch area on a topographic base.
