MEMORANDUM

To: Brian Hunt, BSEACD
From: Tom Grimshaw
Subject: Report for Halifax Ranch Field Trip, December 1, 2015. Attendees: Brian Hunt, Brian Smith, Justin Camp, and Tom Grimshaw

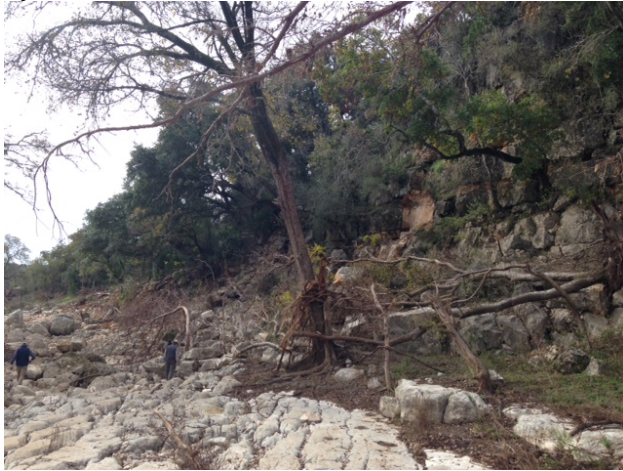
- Observed dipping beds northwest “into” the fault – reverse drag (typical in Balcones Fault Zone).
 - Apparent Edwards outcrop on both sides of the fault in creekbed.

A. Westward view showing fault at location behind tree. Note that the massive limestone beds on the left side of the photo are truncated by the fault.

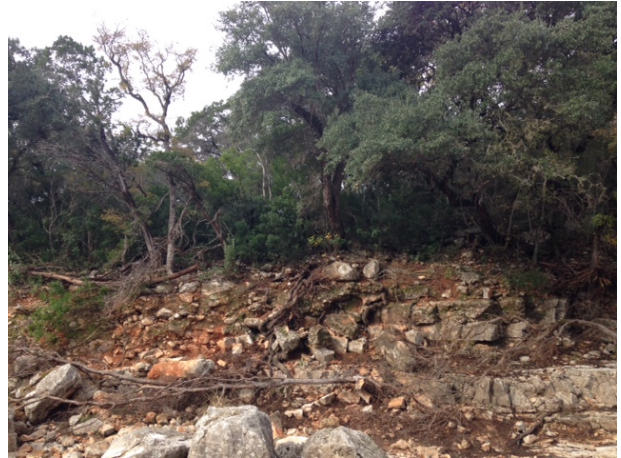
- Examined fault outcrop in creek bed just upstream of Halifax Road bridge over Halifax Creek.
 - Observed “shattered” zone on west bank just below end of competent beds.

B. Closer view of the “rubblized” zone associated with the fault, which is on the right side of the photo.

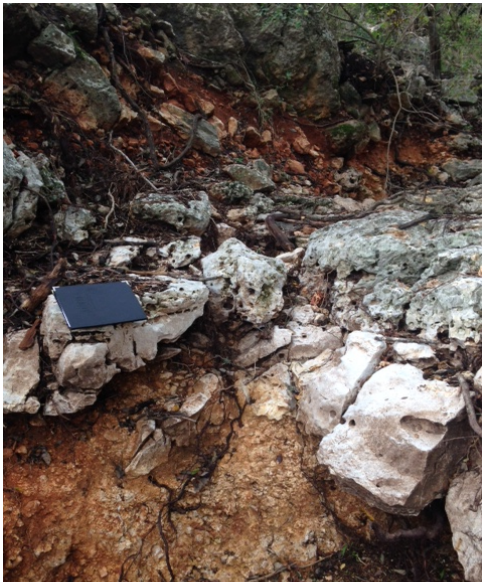
- Observed apparent fault gouge and terra rosa staining associated with the fault, both in Halifax Creek and in small stream flowing in from the west.

C. Outcrop of apparent fault gouge (pink material in lower part of photo) in small tributary at fault location.

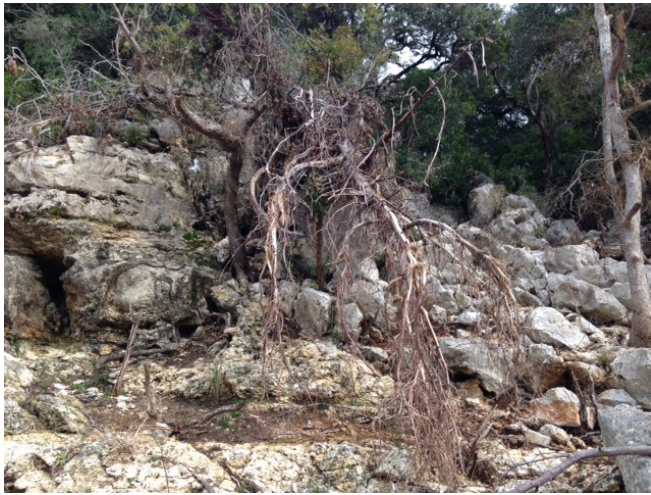
- Observed apparent fault gouge, terra rosa stain, and dipping beds in bed of tributary in hike down to the river.
 - Found outstanding exposure of major fault with Edwards limestone downthrown to the east against Glen Rose formation. Hunt measured strike and dip of fault with Brunton compass; found N30E and 74SE. Edwards is therefore hanging wall over Glen Rose footwall.

A. North view from edge of the river. Outcrop on left side of photo is upper Glen Rose dolomite. Limestone outcrop behind the tree (photo center) is Edwards limestone.

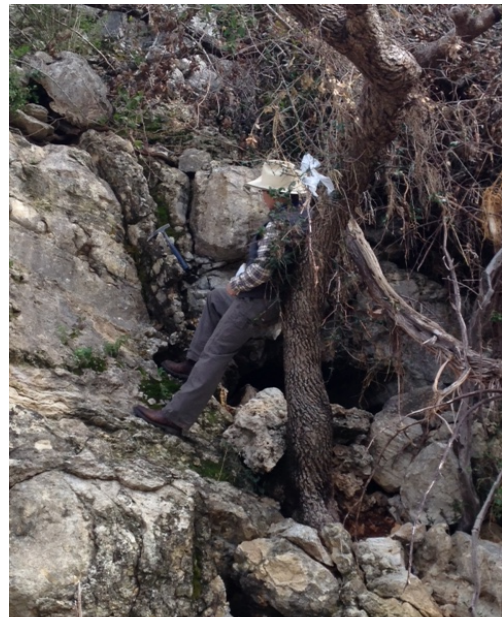
B. Closer view of fault exposure. The fault zone is in front of Brian Hunt. Behind him is the Edwards limestone. On the left side of the fault (where his foot is planted) is the Glen Rose formation.

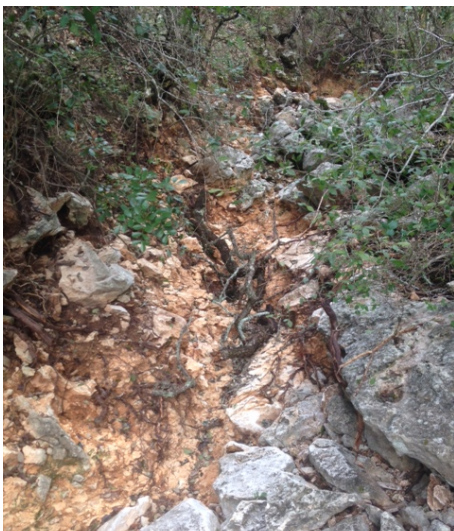
C. Outcrop of apparent fault gouge in the streambed of the small tributary to the Blanco. Note beds dipping to left (west) toward fault gouge.

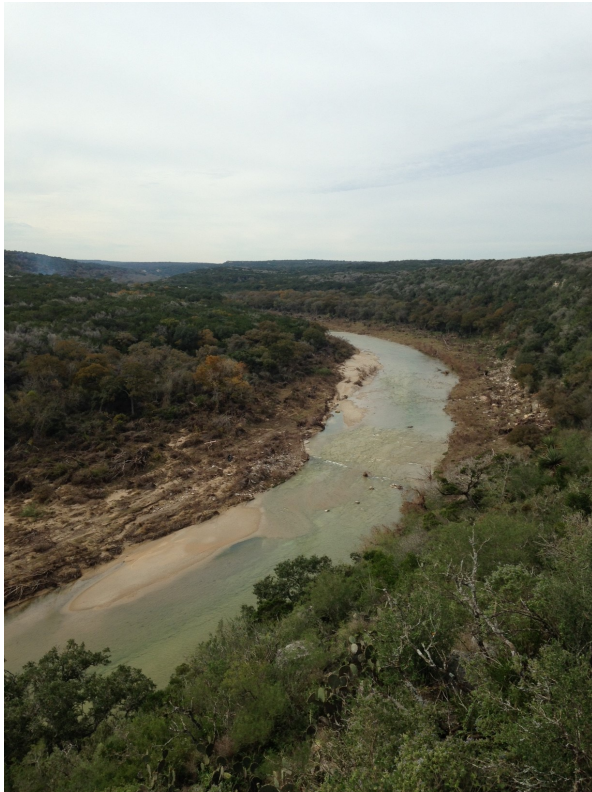
- Small apparent fault visible in upriver photo.
6. Stop 6. Massive Beds and Apparent Fault on North Side of Blanco River Near Halifax Ranch
 - Outcrops examined going back downriver to Halifax Ranch home. Massive beds observed most of the distance.

A. Upriver (Westward) View. Note small falls in riverbed, the apparent location of a small-displacement fault.
