MEMORANDUM

To: Brian Hunt, Brian Smith, Justin Camp (BSEACD)
From: Tom Grimshaw
Subject: Report for Barber Falls Field Trip, December 16, 2015.
Attendees: Brian Hunt, Brian Smith, Justin Camp, and Tom Grimshaw

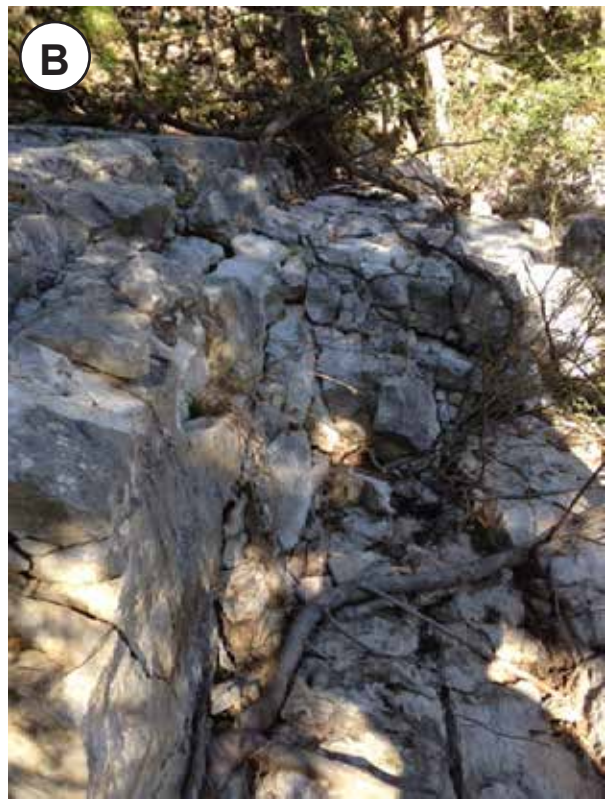
Fault zone just to the east of Barber Falls. Trend is ~45NE.

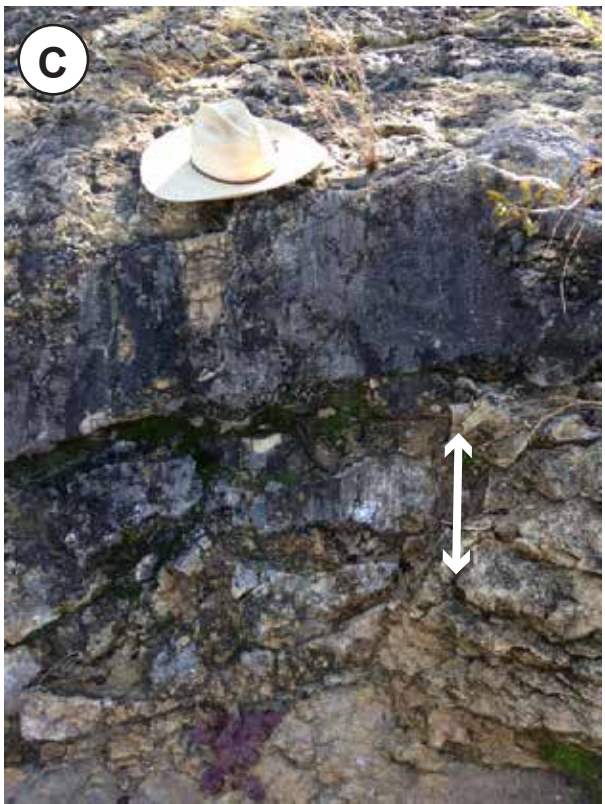
Fault scarp in the Georgetown with numerous slickensides. General orientation noted by arrow.

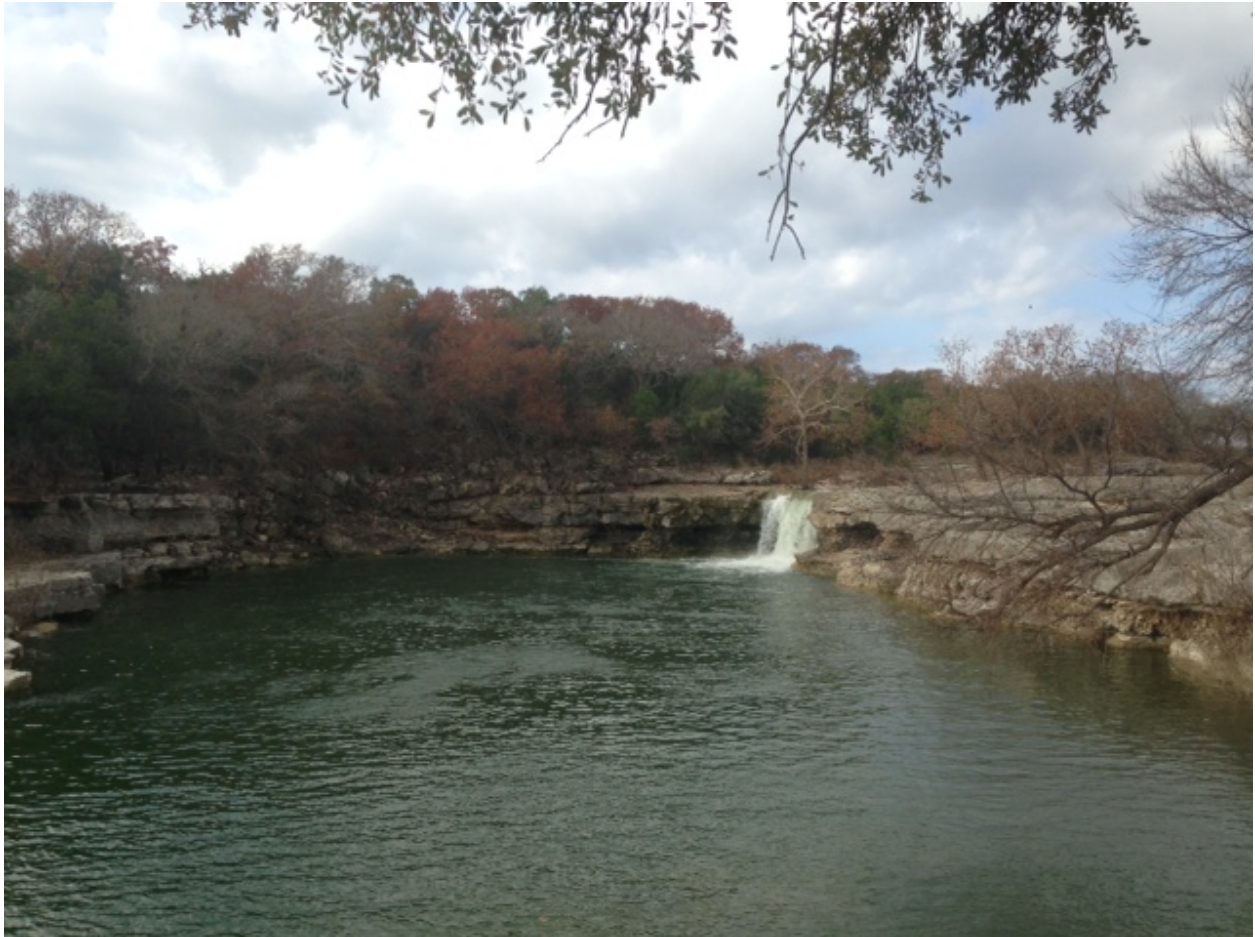
Attachment C.
Lower Falls

- Again a photo stop in part. See Attachment C.
- Pool into which the cascade is flowing is likely to be a former collapsed sinkhole, as observed previously
- Observed small-displacement fault at falls location. Hunt obtained strike and dip: N40°E, 12°SE. Photo in Attachment D.
- Had extensive discussions with Flora Marvin, local resident providing Barber Falls access.

Note: The pool is over 20 feet deep and is apparently filling a collapsed former cave or sinkhole. View is generally to the southwest. Photo courtesy of Brian Hunt.

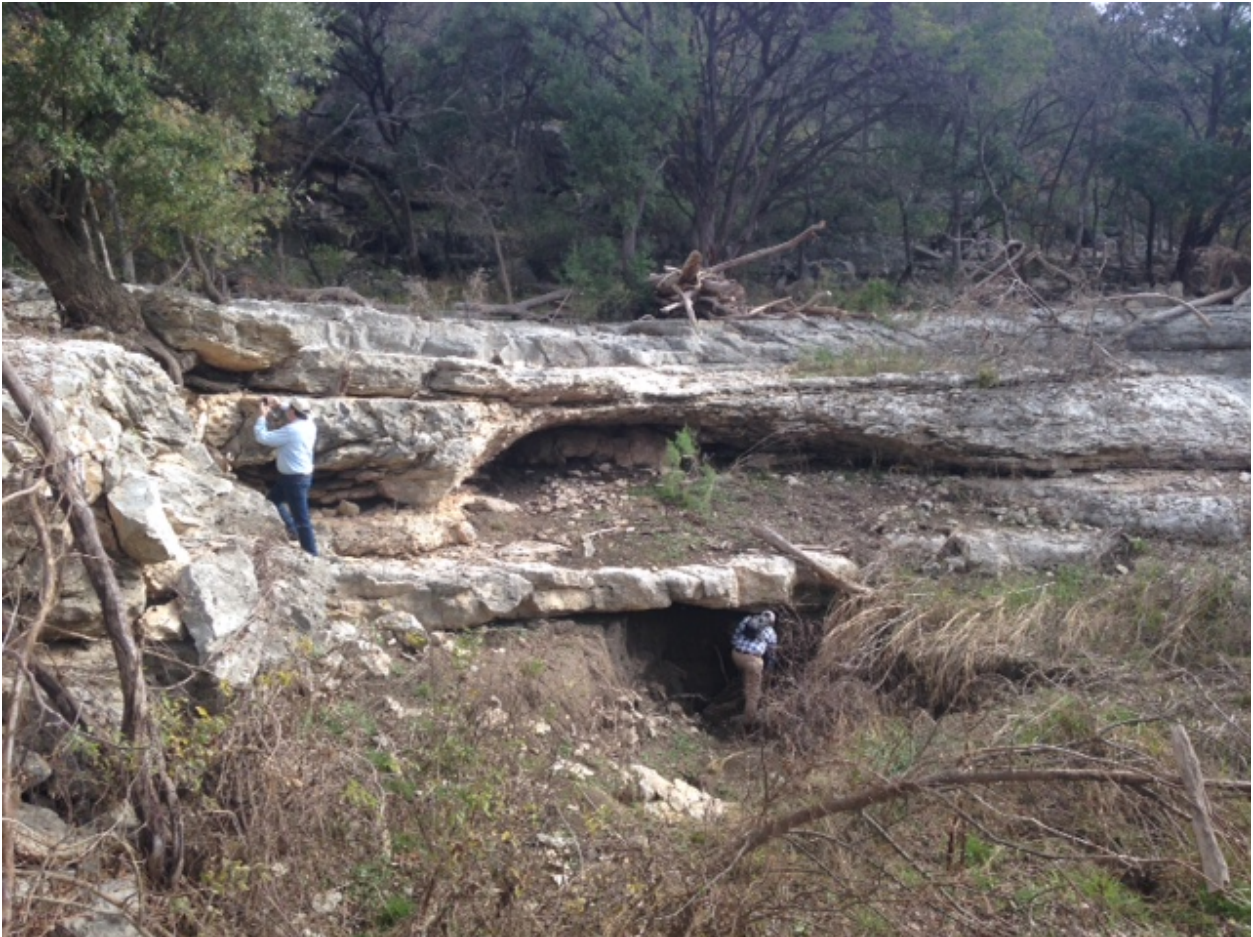
Attachment D.

Small-Displacement Fault at Lower Falls

Note: Smith is on the left and Camp is on the right. The fault can be seen just to the left of Smith. View is generally northward. Photo courtesy of Brian Hunt.

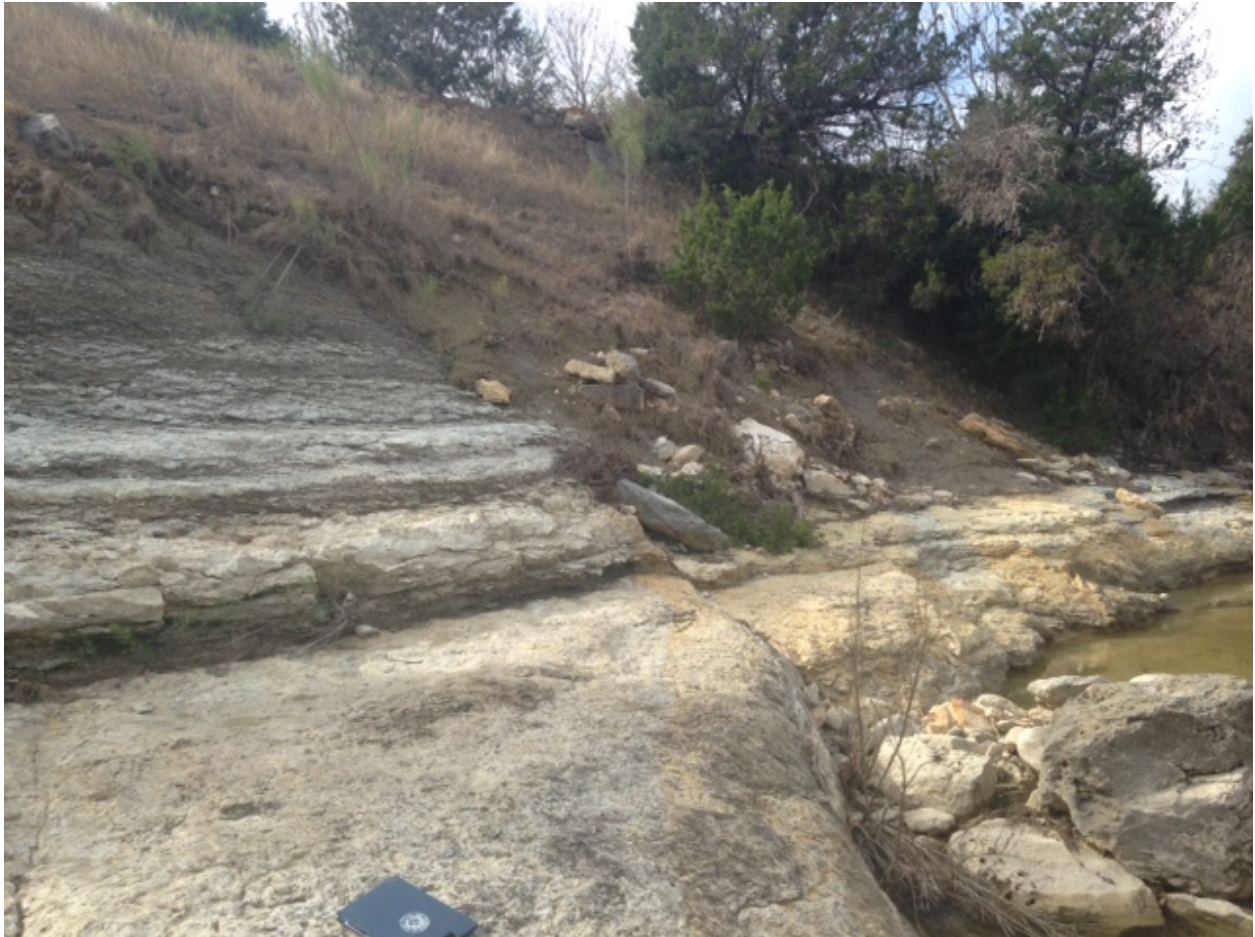
- Hunt crossed the creek to south bank in spite of considerable flow to examine Georgetown-Del Rio exposure and fault outcrops. Obtained strike and dip of two small displacement faults: both N40°E, 60°NW. Photo is in Attachment E.
- Camp photographed small slump in Del Rio outcrop (Attachment F).

Georgetown and Del Rio Outcrops on South Bank of Onion Creek below Barber Falls

Note: Exposed fault, shown in the center of the photo, is downthrown to the west, which is atypical for the Balcones Fault Zone. The Georgetown formation crops out in the foreground on the upthrown side of the fault. The Del Rio (above the Georgetown) is on the downthrown side in the background. View is generally to the southwest. Photo courtesy of Brian Hunt.

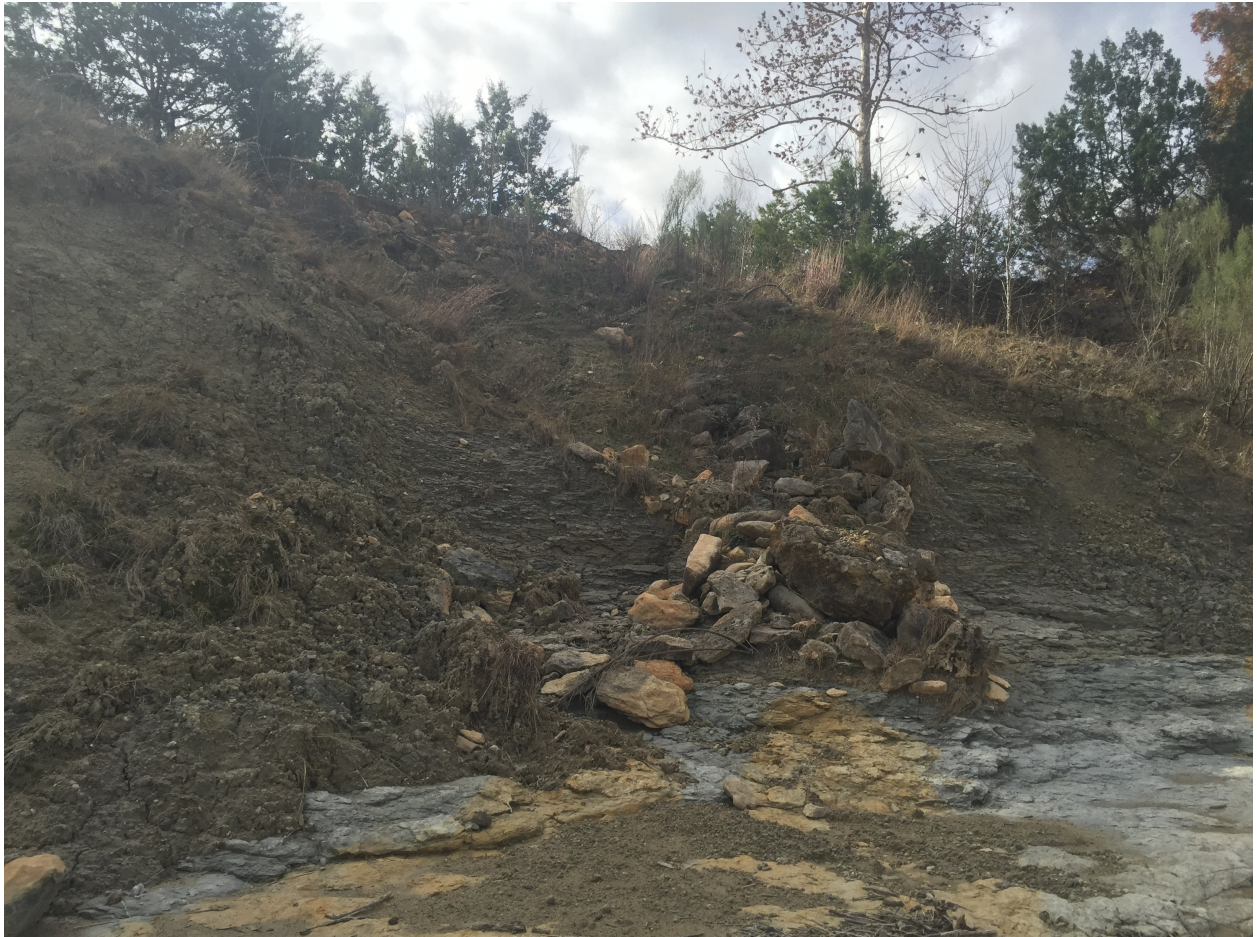
Attachment F.

Slump in Del Rio Outcrop on North Bank of Onion Creek

Note: Slump is shown in central portion of photo. Picture courtesy of Justin Camp.
