MEMORANDUM

To: Brian Hunt,
From: Tom Grimshaw
Copy: Brian Smith, Justin Camp
Subject: Field Trip Stops, Day 2 (May 10) At Rutherford Ranch

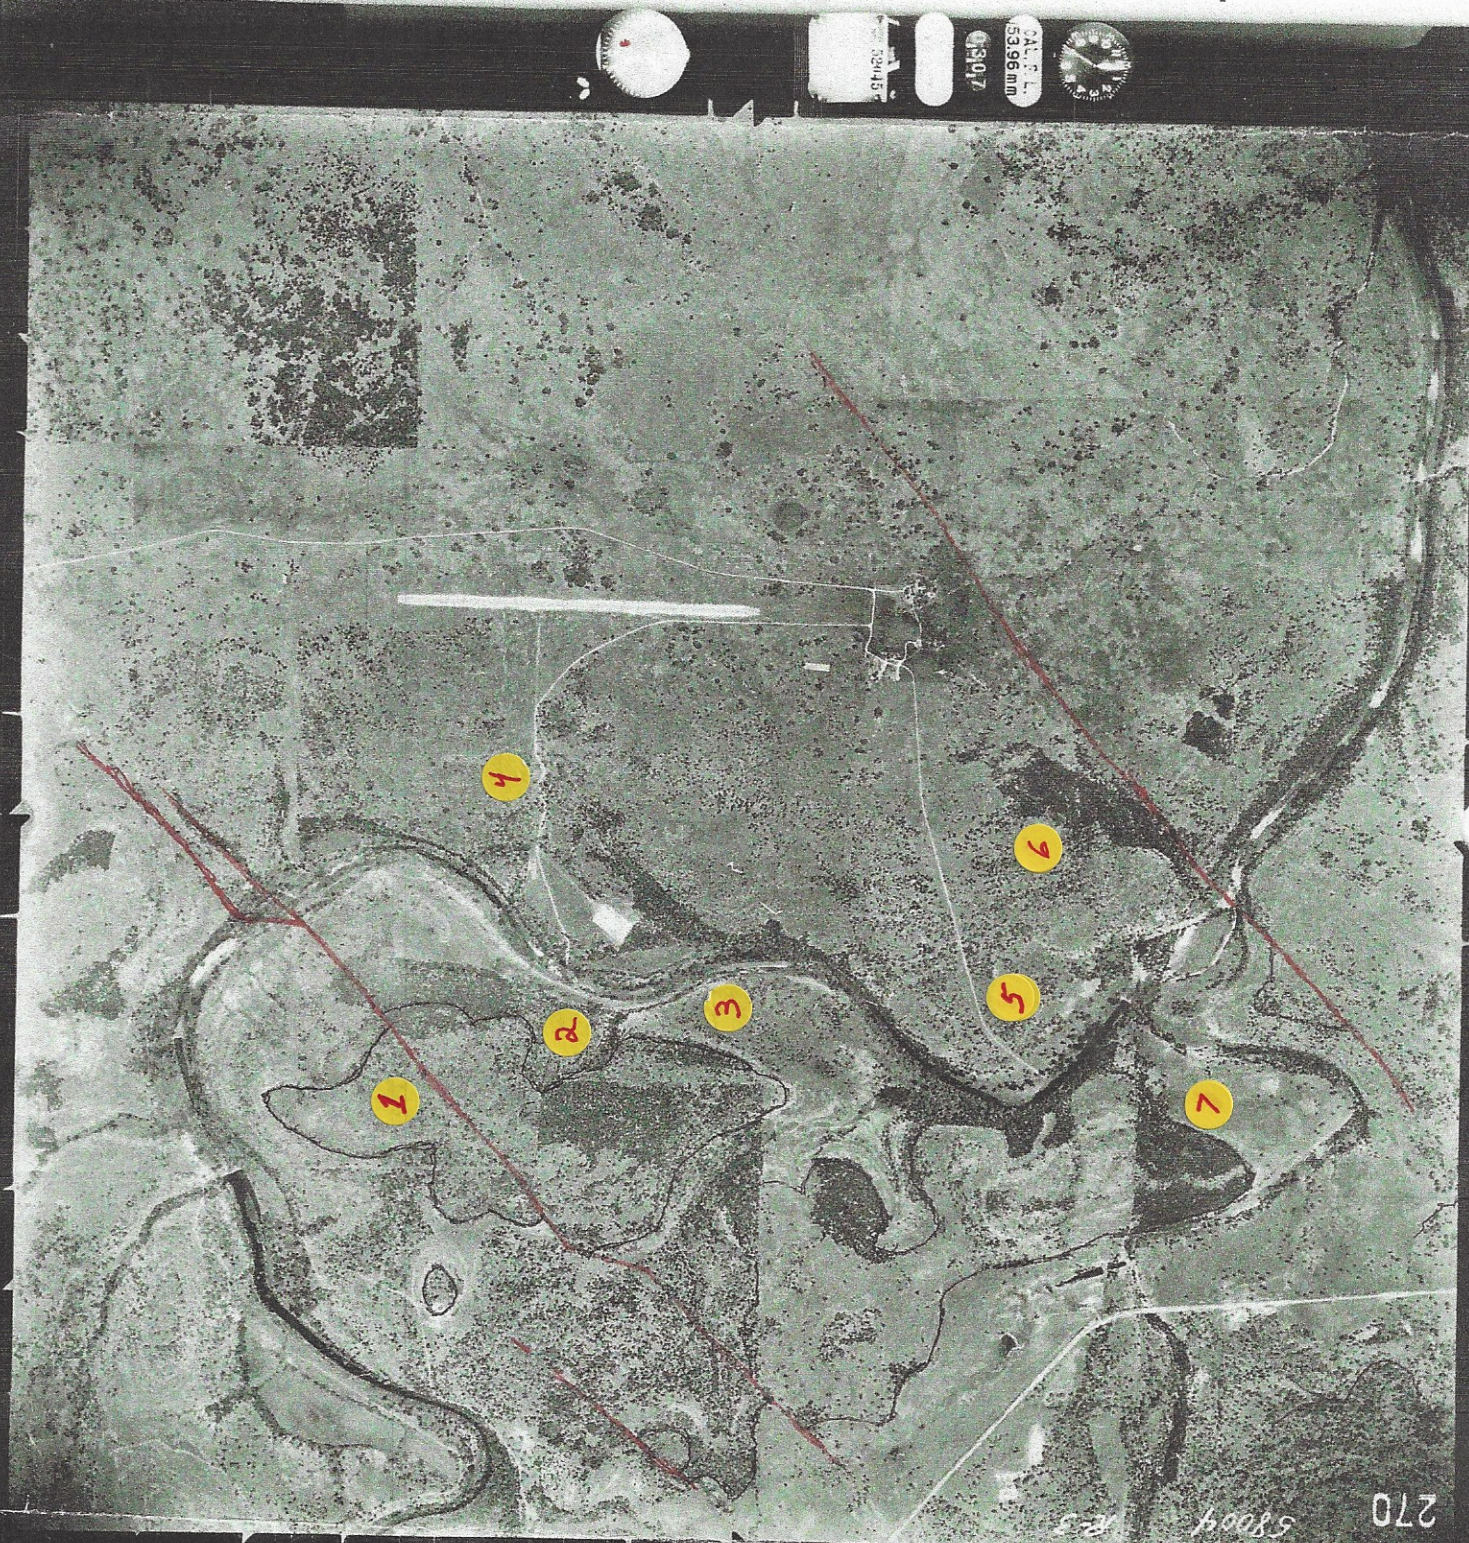
Attachment A.

1. Check of Walnut-Edwards contact. Concluded there is no Edwards; the hilltop is underlain by the Walnut, with a Glen Rose – Walnut contact on the hillside. Remapping is required.
2. Confirmed (by Hunt) Walnut-Edwards contact as mapped, particularly at grotto at head of small ravine.
3. Small-displacement fault crossed by Onion Creek, apparently as mapped by Hauwert and others. Will be added to air photo mapping.
4. Apparent confirmation (by Hunt) of small-displacement fault, but further up on the hill.
5. Possible confirmation of Walnut-Edwards contact on hillside.
6. Ravine examination for evidence of faulting, which was observed in upper reaches of creek.
7. Walnut-Edwards contact confirmation (by Hunt)

Find
Kwa-
Ked

Find Kwa-
Ked

Is this
natural?

Look for
fault,
evidence

Conf
Kwa-
Ked
both
sides

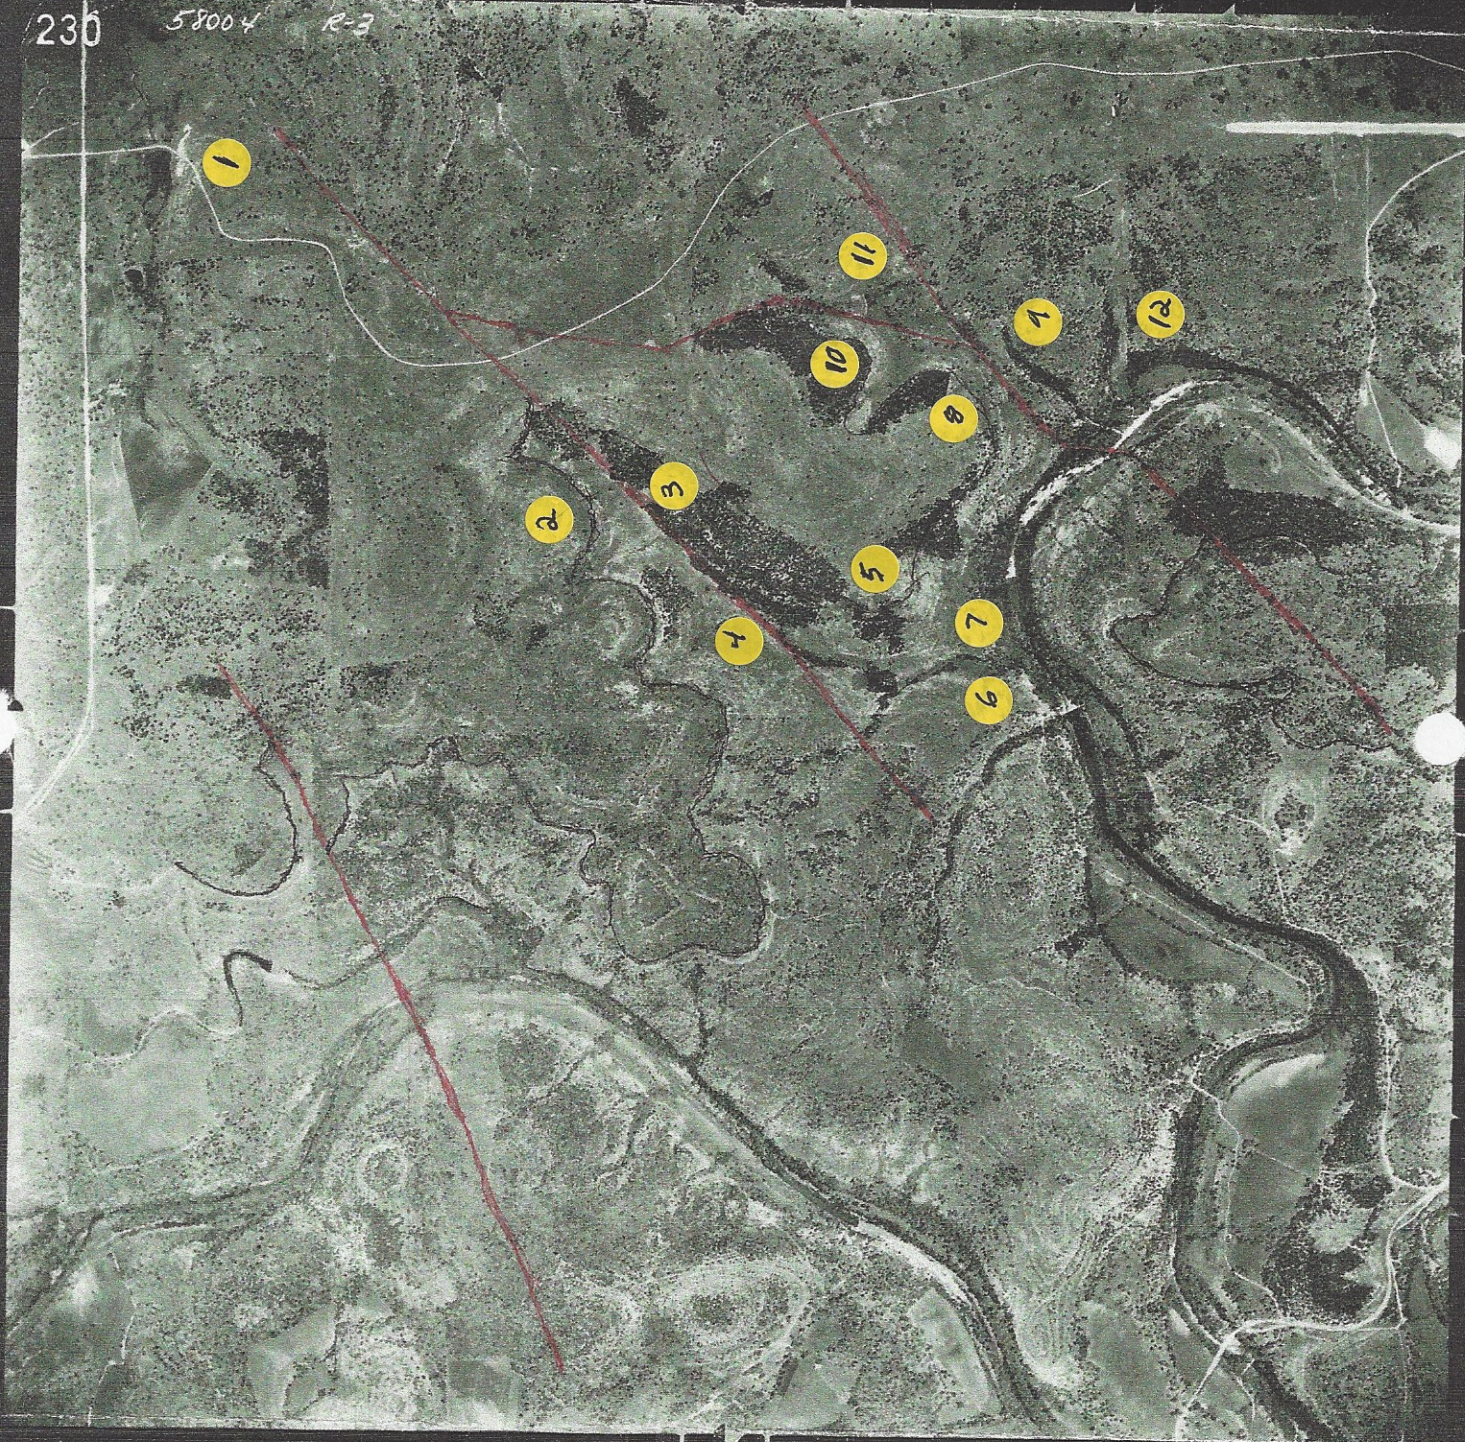
Attachment C.

1. Walnut-Edwards contact on the hill south of the entrance gate. There are two candidate ledges for the contact, but for 1:24,000 scale mapping, the location of the contact will not be greatly affected.

2. Walnut-Edwards contact west of main road into Ranch on upthrown side of fault.
3. Walnut outcrop on east side of fault, demonstrating the existence of the fault. Top of Walnut difficult to discern on hillside.

4. Fault outcrop observed by Brian; exact location uncertain.
5. Walnut-Edwards contact on south side of hill.
6. Outcrop of highly weathered alluvium – Onion Creek terrace – on hillside. Former borrow pit.

7. Glen Rose outcrop, 8-10 foot high vertical bank, on east side of small tributary to Onion Creek. Flaggy beds noted.
8. Walnut-Edwards contact on road leading down hill.

9. Deeply cut ravine. No evidence of faulting, which confirms fault location northwest of the ravine. Location confirmed by Brian. Walnut-Edwards contact apparently at top of “grotto” at head of ravine.

10. Walnut-Edwards contact on hill.
11. Walnut-Edwards contact on east side of small drain where stock tank has been built. Demonstrate that cross fault is not needed.

12. Walnut-Edwards contact walked by Brian to small tributary to Onion Creek.

Verify Red
Kwa-Ked
both sides
of fault

Verify
Kwa-Ked

Look for
fault
evidence
