MEMORANDUM

To: Brian Hunt, Frank Davis
From: Tom Grimshaw
Subject: Dahlstrom Ranch Field Visit, September 16, 2016

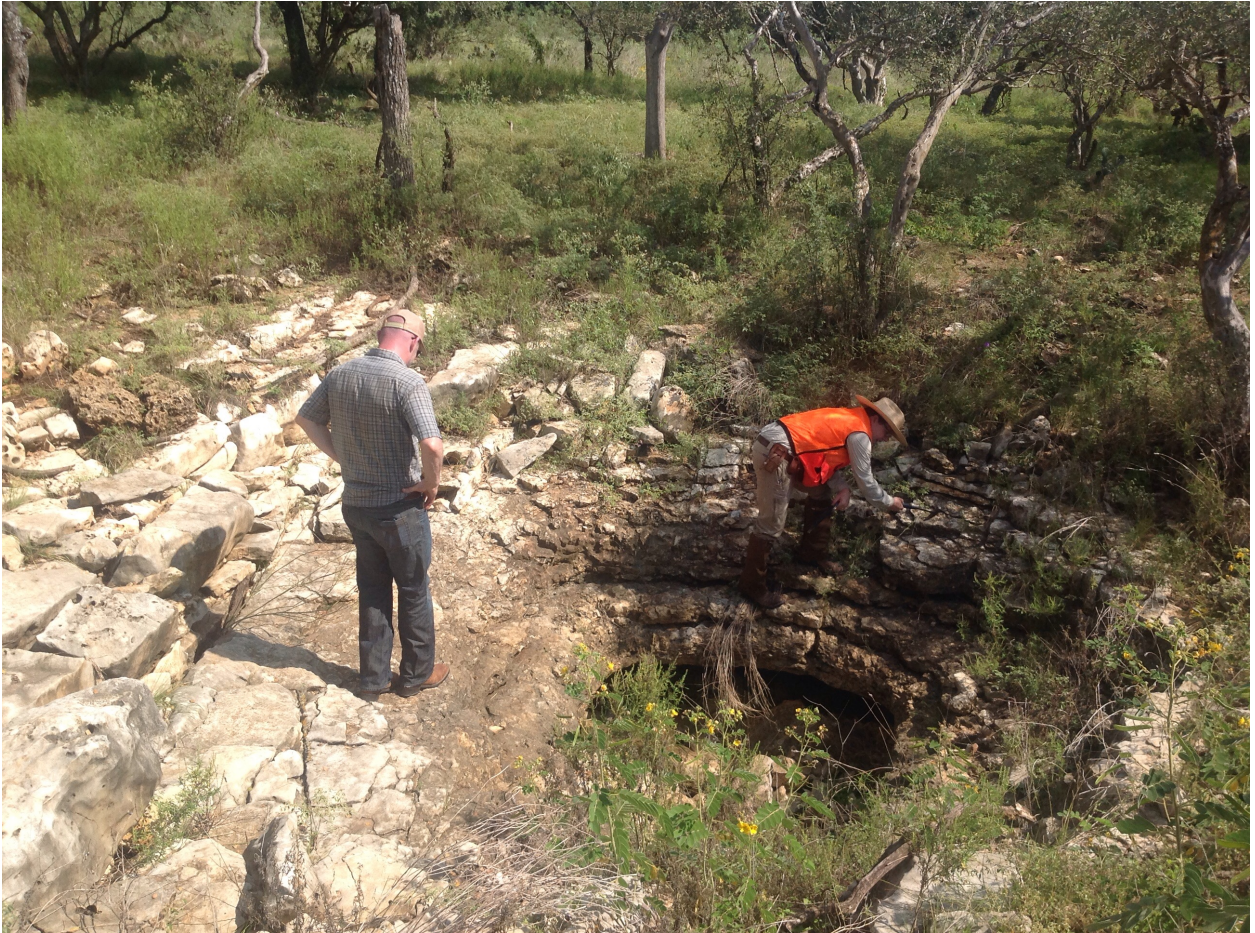
Attachment B.
Persimmon Cave

- Signed in at the kitchen of the Ranch main facility (Attachment A)
- Walked north to visit Persimmon Cave. Noted Edwards or Georgetown outcrop at cave mouth (Attachment B)

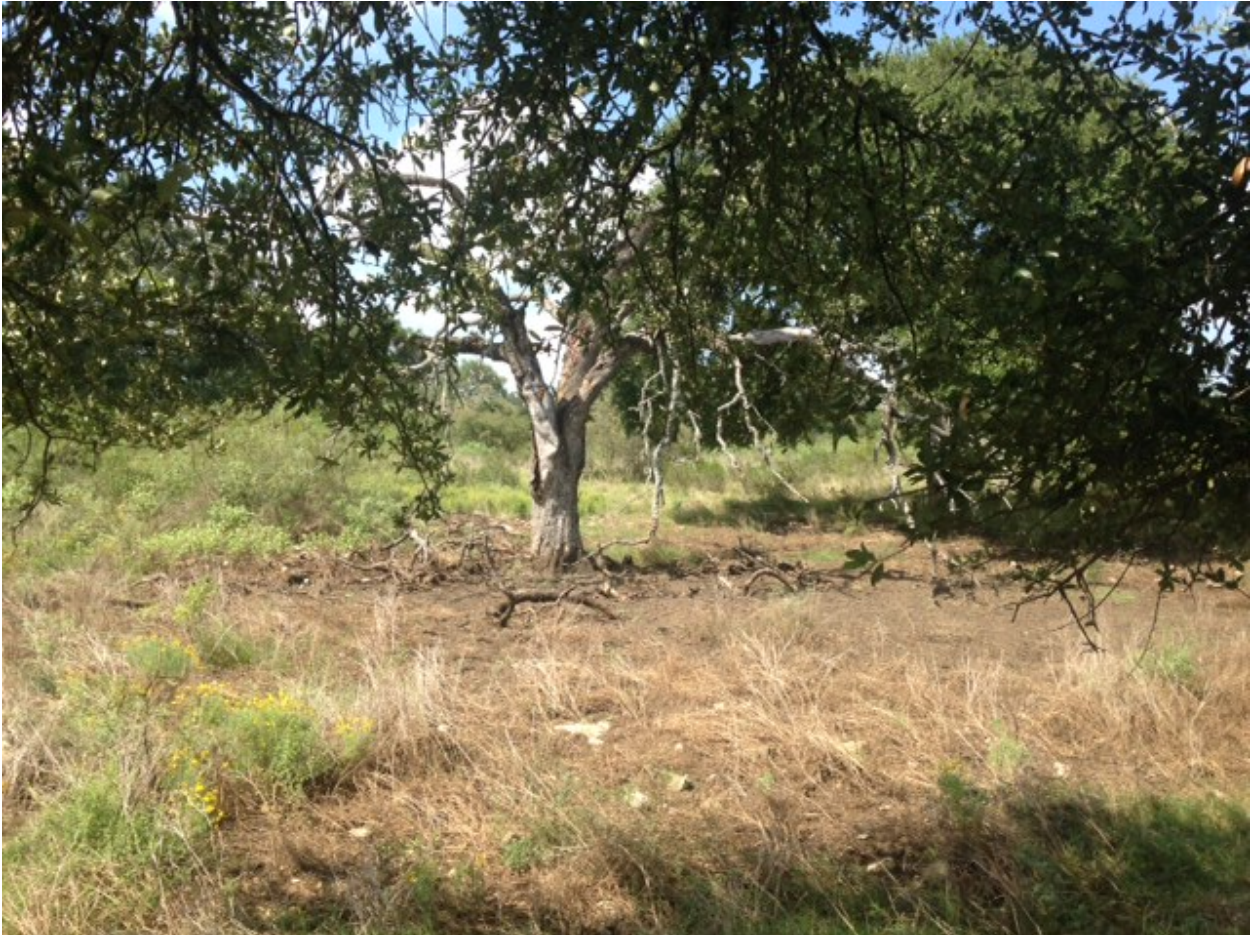
Attachment C.

- Frank and Tom photographed a sinkhole on the road leading south from Carpenter Hill (Attachment C).
- Brian photographed a small spring in Del Rio on Carpenter Hill below the water tower (Attachment D).

Sinkhole on West Side of Road Leading South of Carpenter Hill

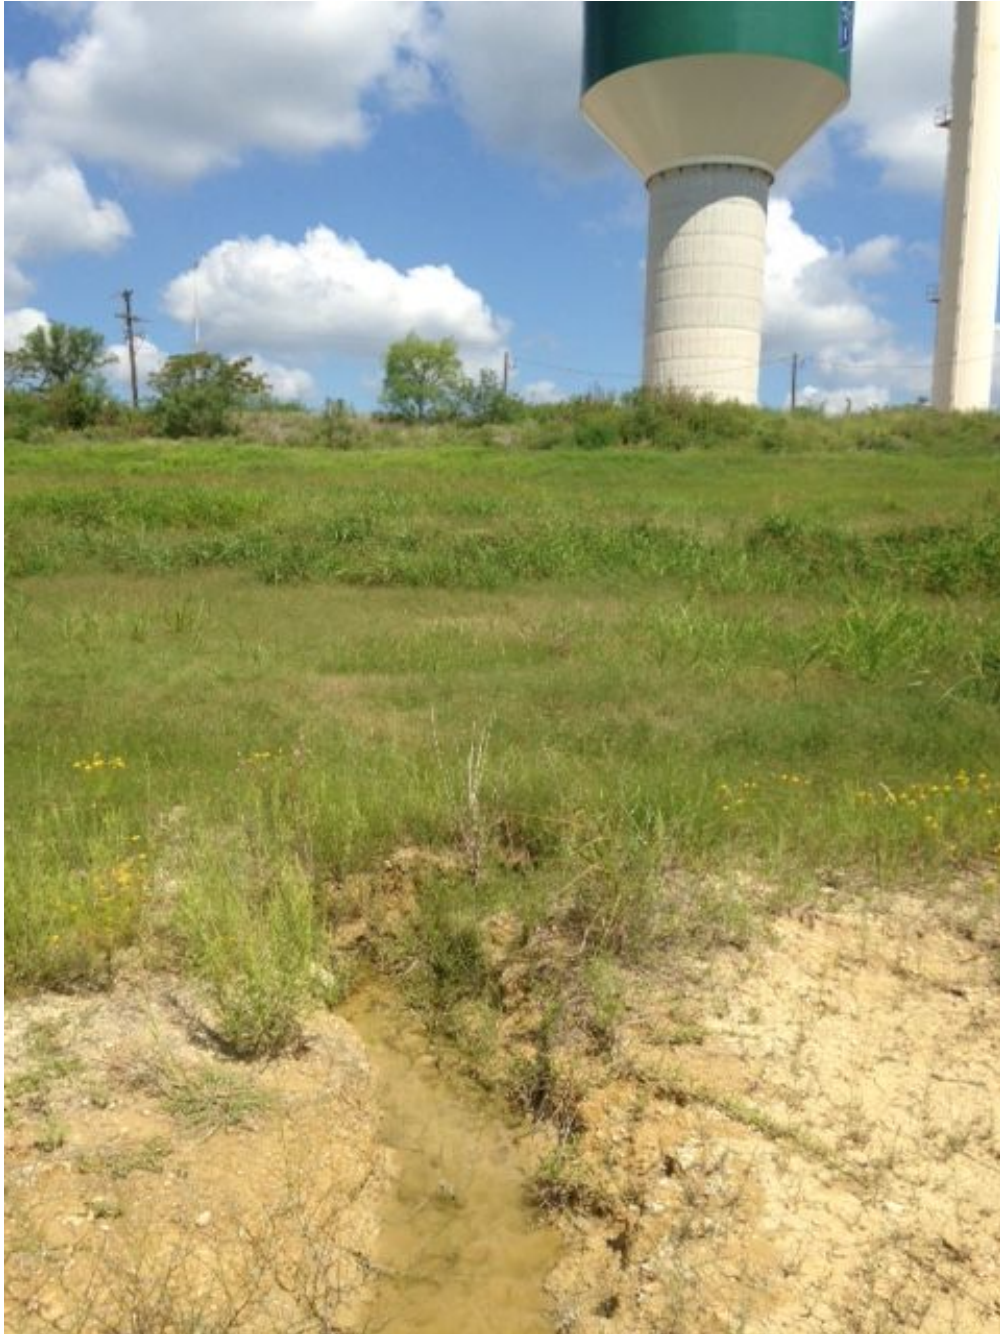
Attachment D.

Small Spring in Del Rio on Southwest Side of Carpenter Hill

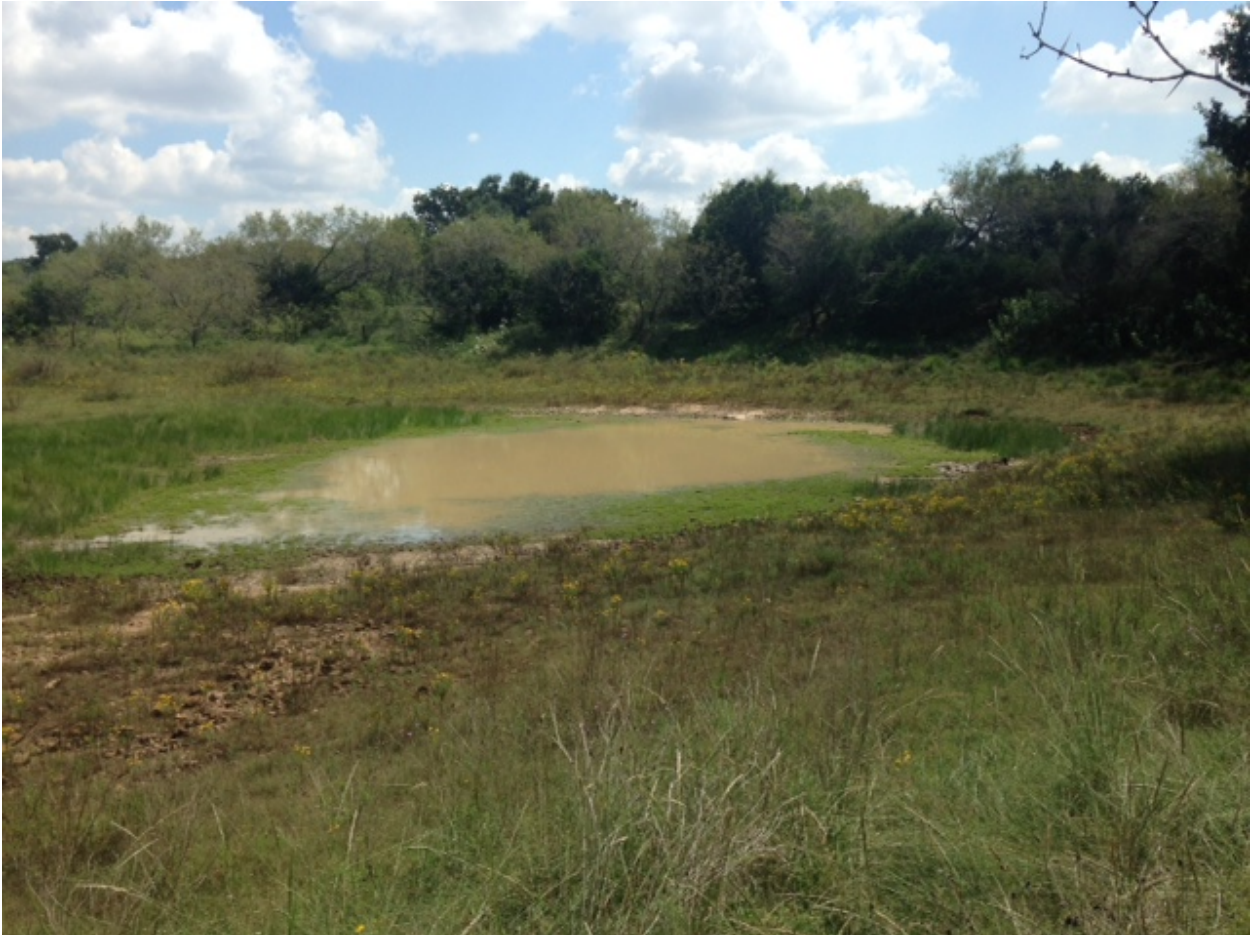
Attachment E.
Horseshoe Sinkhole

- Met at Horseshoe Sink. Photographed the pond at the sink and the recharge crevice in the Georgetown formation, located north of the pond (Attachments E and F)

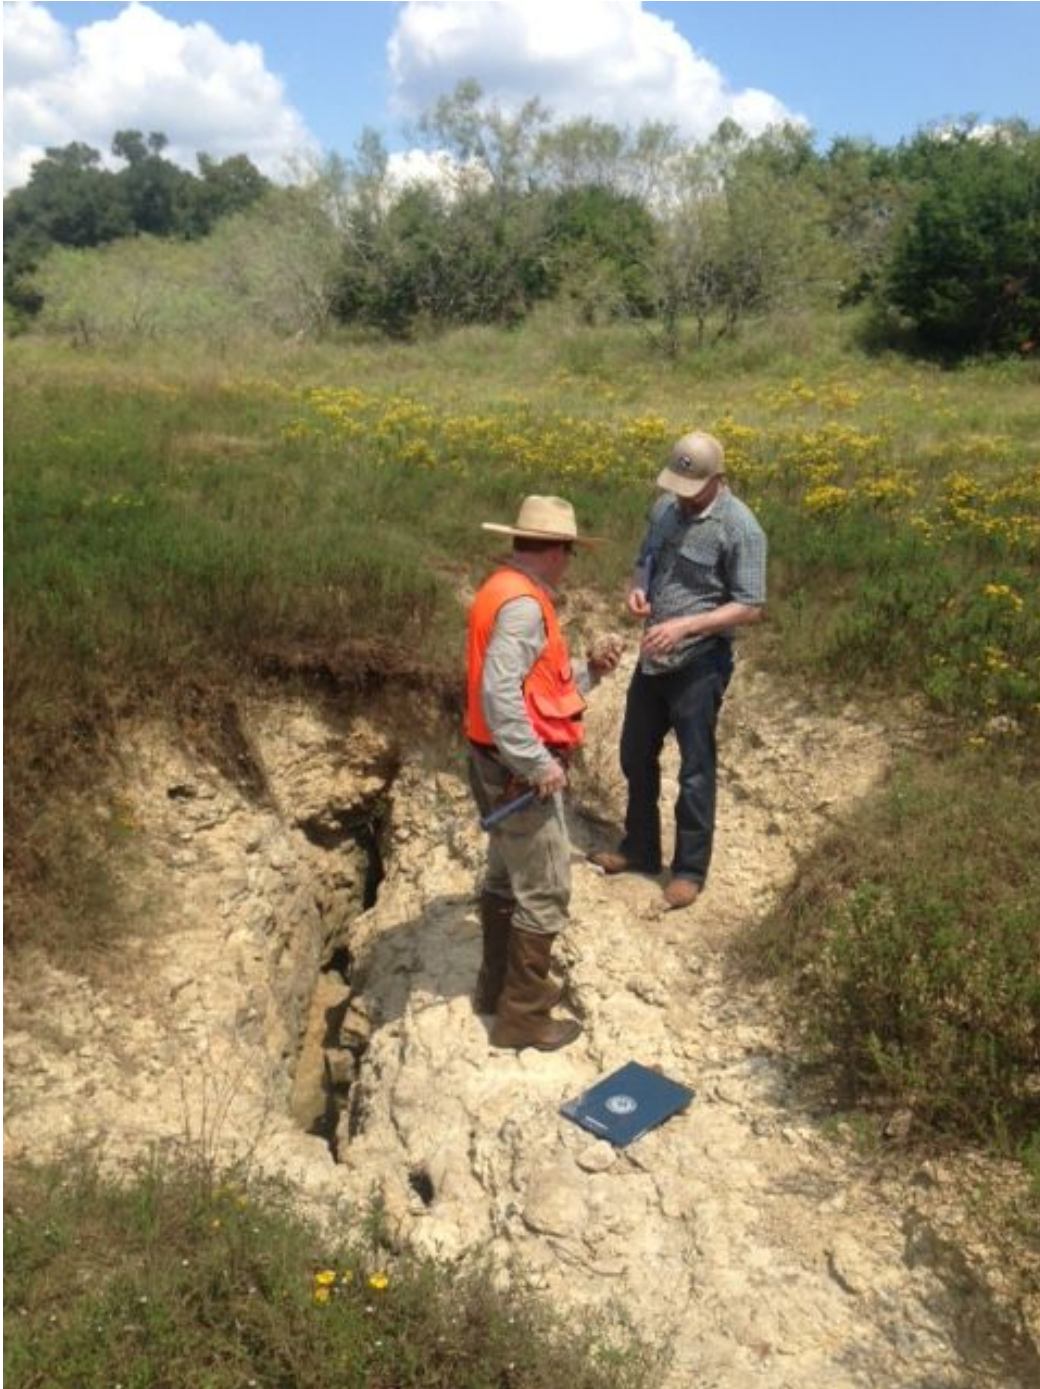
Attachment F.

Recharge Point North of Pond in Horseshoe Sink

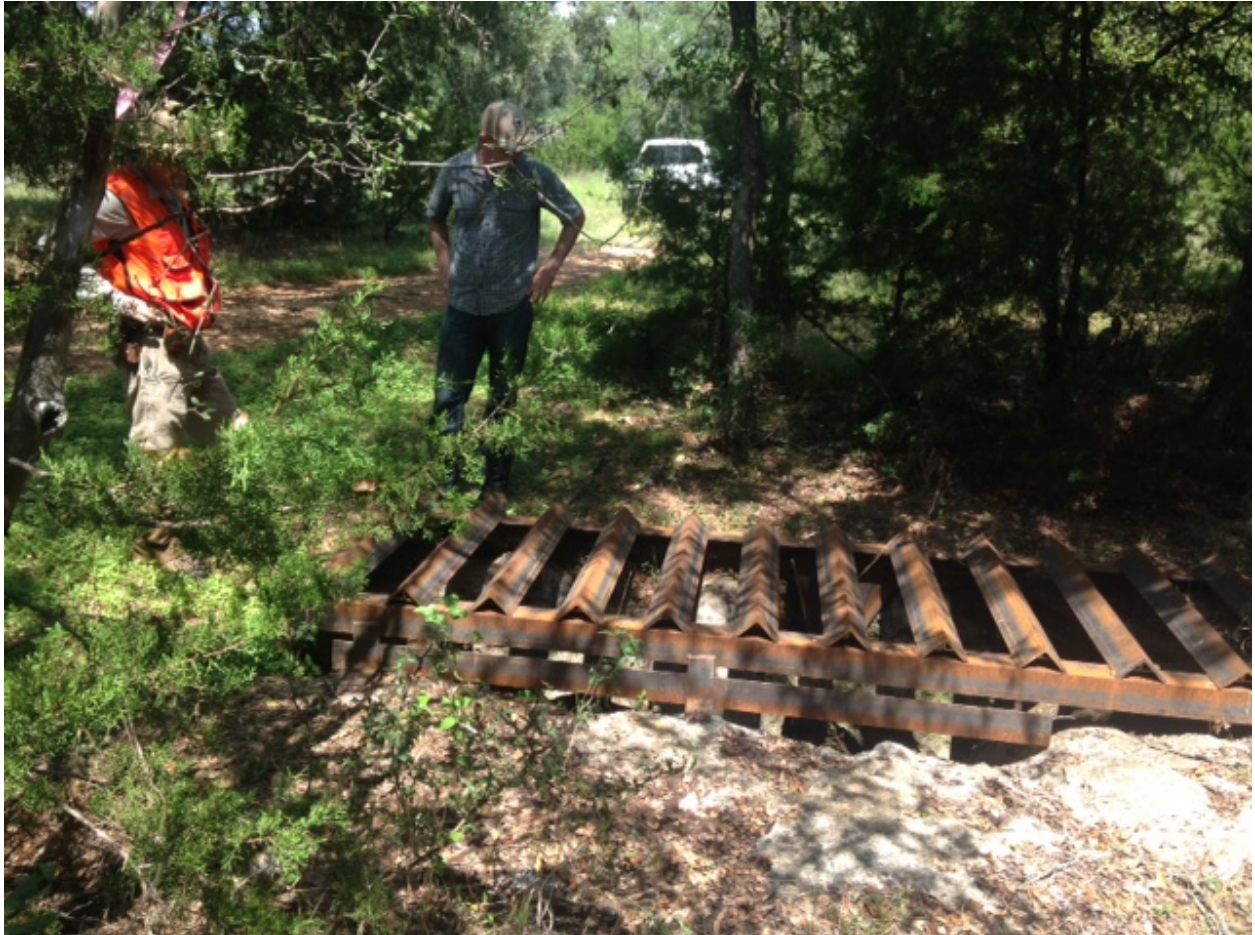
Attachment G.
Cave Gate over Road Sink

- Drove north from Horseshoe Sink and confirmed Edwards on the west side of an apparent fault. Turned around at entry gate off FM967
- Returned to Ranch facility. Stopped to photograph cave gate over “Road Sink” on the way (Attachment G).
